HISTORIC STRUCTURE REPORT  
FLUVANNA COUNTY HISTORIC COURTHOUSE  
COUNTY OF FLUVANNA, VIRGINIA

# FLUVANNA COUNTY HISTORIC COURTHOUSE

## HISTORIC STRUCTURE REPORT

September 7, 2022

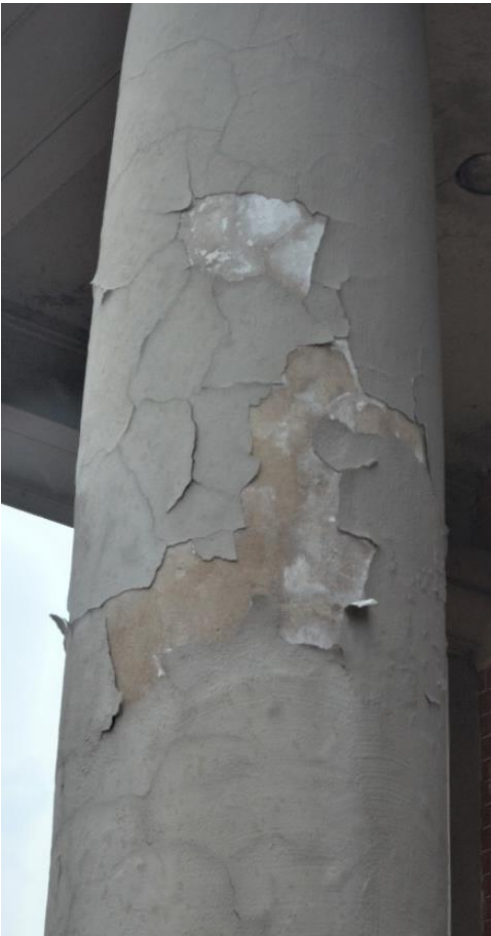
<p>Existing stucco surface at all columns and pilasters display extensive delamination of paint and finish stucco coat.</p> <p>Perform selective removal of stucco at columns to determine to confirm binder. Complete petrographic analysis to determine composition of stucco. This analysis will determine if a lime mortar was used. An inappropriate material such as Portland cement may have been used, leading to the finish issues. It may be necessary to remove the existing stucco from columns and pilasters to the brick substrate. If the composition of the stucco is appropriate, the issues may stem from application of the modern paint coating. To resolve this issue, remove paint and finish surface with breathable paint.</p>	<p>Small area of selective removals and petrographic analysis of existing stucco. Surface prep and repainting of all columns and pilasters.</p>

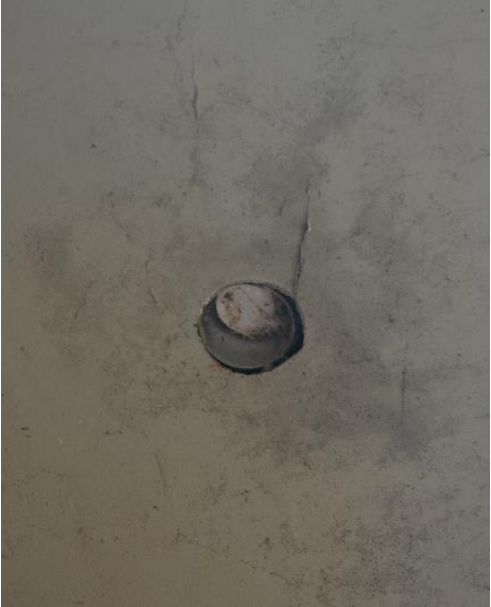
<p>Existing portico stucco ceiling displays finish deterioration and localized areas of cracking.</p> <p>Gently sound damaged areas of stucco ceiling surfaces to determine extent of delamination. Remove loose or damaged areas of stucco. Prepare wood lath substrate to allow for sufficient bond with new stucco. Saturate wood lath with water in advance. Provide new stucco surface that matches composition and texture of existing stucco. Paint 100% of ceiling using breathable paint.</p>	<p>230 SF of repainting / 20 SF of repair</p>

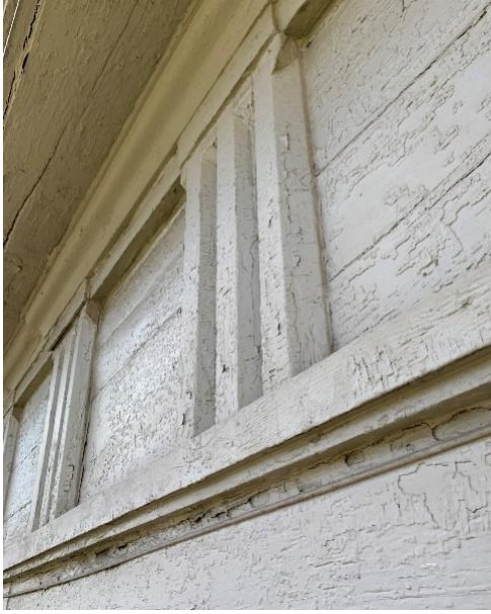
Existing wood cornice, pediment, and tympanum display varying degrees of failure of the existing painted finish.  Since much of paint history was previously removed from these areas, scrape strip 100% of deteriorated paint finish. Assess wood substrate. Repair minor surface damage. Remove rotted elements and provide wood dutchman. Prepare wood surface for new sanded paint finish per original design. Repaint.	1,500 SF of repainting / 25 LF of repairs
WD.3

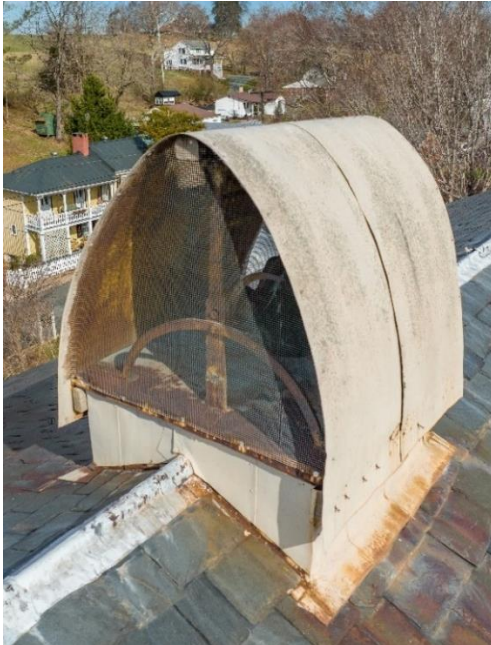
<p>The sheet metal bell enclosure displays corrosion and finish deterioration. The existing roof opening for the bell rope is allowing water to migrate into the building.</p> <p>Remove corroded sheet metal bell enclosure. Provide new enclosure. Determine design of new enclosure. Assess bell and mounting. Determine ability to reuse roof panels. Include attic vent and metal roof flashing at base of new enclosure. Provide flashing and sealant to create weatherproof opening for bell rope at horizontal metal surface.</p>	<p>1 location (approx. 20 SF footprint)</p>
<p>MT.3</p>

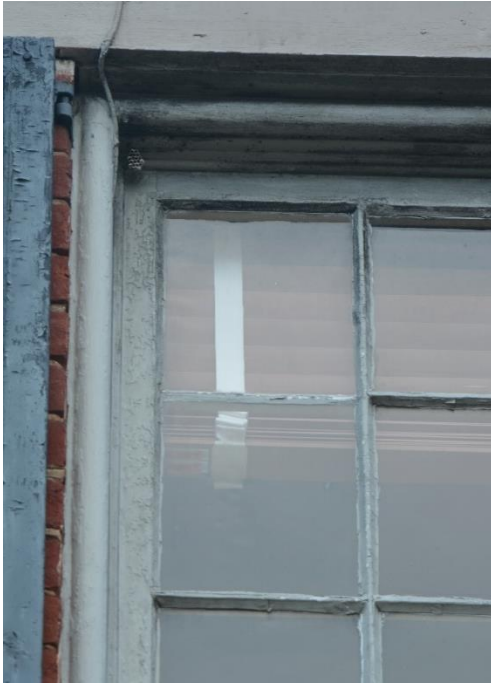
<p>Existing wood windows display finish and substrate deterioration at various components.</p> <p>Restore 100% of wood windows. Remove window sashes. Remove glazing putty and glass. Label and store glass for future reinstallation. Strip paint. Remove rotted wood from sash and frames. Remove perimeter sealant. Provide epoxy patch for all surface repairs and wood dutchman for rotted sections. Reglaze sash. Paint all sides of frame, sill, and sash. Reinstall sash. Provide perimeter sealant.</p>	<p>8 double-hung windows @ 25 SF each / 10 casement windows @ 15 SF each / 4 transoms @ 10 SF each</p>
W.2

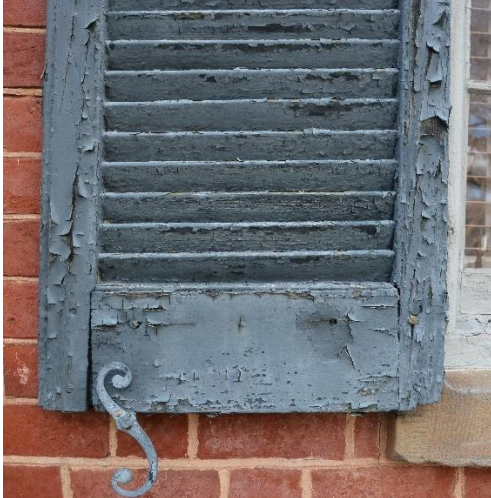
<p>Existing wood shutters display finish deterioration and apparent signs of wood rot.</p> <p>Restore wood shutters. Remove all painted wood shutters. Repair shutter hardware and secure any loose shutter dogs. Strip paint. Remove rotted wood. Provide epoxy patch for all surface repairs and wood dutchman for rotted elements. Paint all sides of shutters and hardware. Reinstall shutters.</p>	<p>10 locations @ 25 SF each, 10 locations @ 15 SF each</p>

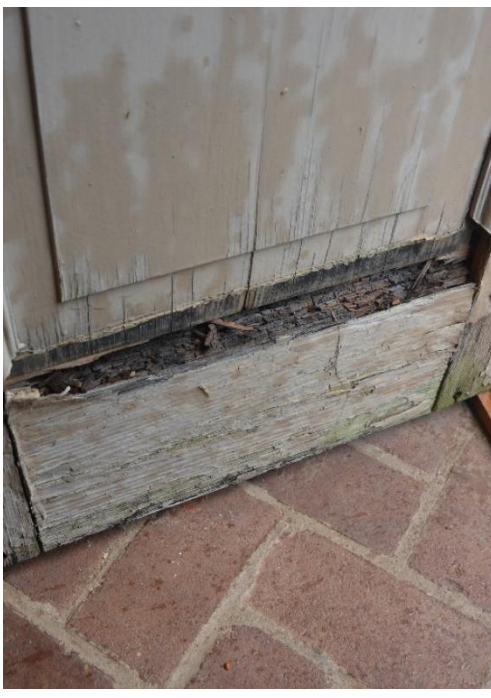
<p>Existing wood doors display finish and substrate deterioration at various elements.</p> <p>Restore wood doors. Remove wood doors. Repair door hardware to improve operability and latching. Remove deteriorated paint from door and frame. Remove rotted wood. Provide epoxy patch for all surface repairs and wood dutchman for rotted elements. Do not strip full surface of doors. Scrape and sand surface to prepare for new finish and paint all sides of door and frame. Reinstall door.</p>	6 doors / Assume replacement of rotted bottom rail at 2 locations and 30 LF of wood door panel molding.
D.2

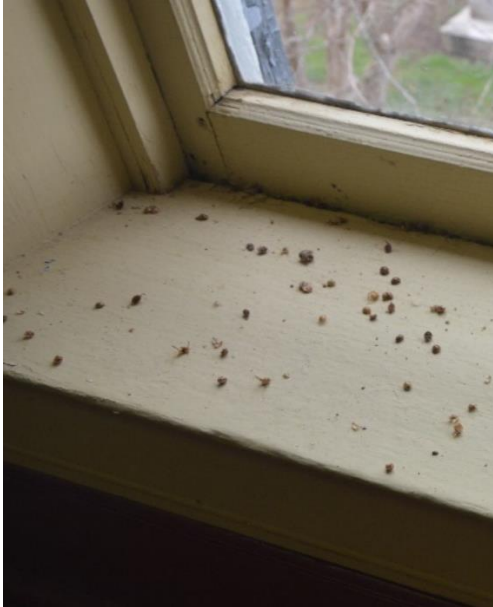
There is a ladybug infestation in the second-floor jury rooms and a wasp infestation in the attic. Although not harmful to the building, it is recommended to remove these infestations.  Address ladybug infestation via vacuum removal, installation of natural or chemical repellent, and/or traps. Perform removal after exterior repairs to prevent future reinfestation. Remove wasp nests from attic and fill openings with appropriate material to prevent additional infiltration.	Upper floor and attic area

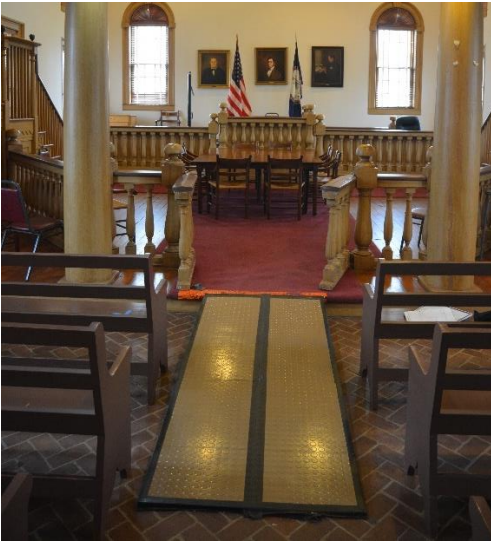
<p>Removeable ramp from brick floor to upper wood floor creates a tripping hazard at wood bench seating and lacks a raised edge or barrier along edge to mitigate fall potential.</p>	1 ramp @ 7 LF, modify three benches to shorten in length, install 3'-0" wide clear swing gate in existing bar
		<p>Remove temporary ramp. Install fixed ramp with handrail at side wall of courtroom. Shorten benches to accommodate ramp location. Modify existing bar to install swinging gate to provide permanent accessible path.</p>

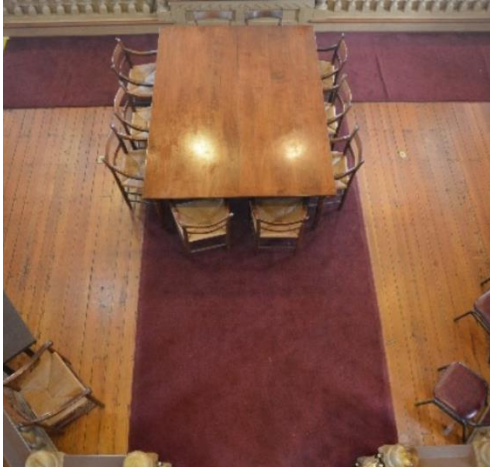
<p>Broadloom carpet covers a significant portion of the wood floor, preventing the ability to assess its condition.</p> <p>Remove carpet to allow for floor refinishing in courtroom, stairs, and gallery. Provide new broadloom carpet at stairs and gallery to protect stair surface from wear and to maximize safety. Return main courtroom floor to exposed wood flooring.</p>	<p>600 SF of carpet removal / 350 SF of new carpet on stairs and gallery</p>
F.7

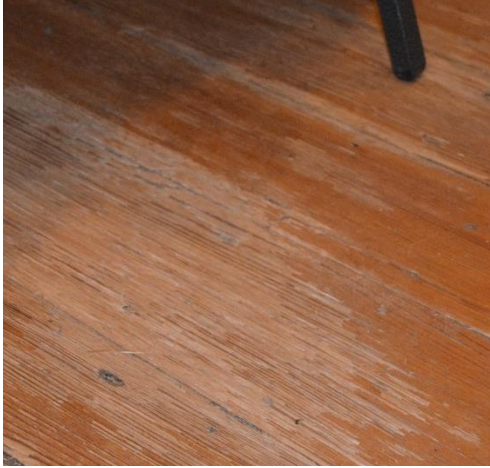
<p>Wood flooring has localized surface damage and gaps between floorboards.</p> <p>Repair and sand area of floor damage. Prepare surface for new flooring finish. Fill gaps measuring 1/4" or more with wood matching in species and graining. Provide new clear high-traffic coating on restored wood floor. Provide foot pads on all furniture.</p>	<p>50 SF of damage / 1600 SF of refinishing</p>
F.8

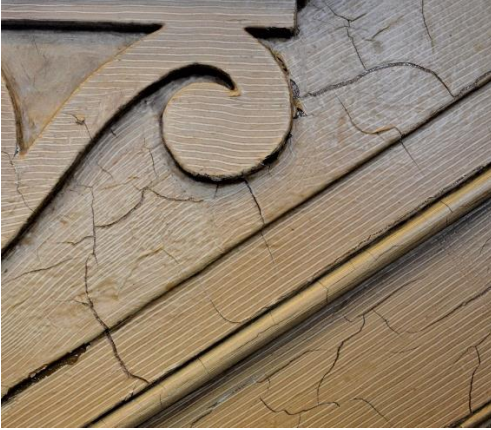
<p>Painted wood graining finish displays deterioration and localized areas of poor execution.</p> <p>Perform interior paint analysis. Remove deteriorated paint finish on all wood surfaces. Prepare surface and repaint 100% of woodwork in courtroom and jury rooms per findings of analysis.</p>	600 SF
WA.2

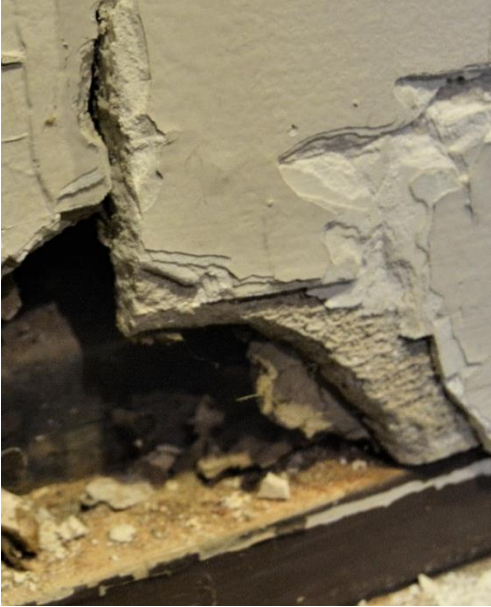
<p>Existing courtroom walls have a layer of plasterboard installed over the historic plaster finish. This alteration has negatively impacted the relationship of between the surface of the wall and the surface of the wood trim pieces.</p> <p>Selectively remove 5'-0" x 5'-0" area of deteriorated wall finish. Assess condition of plaster and masonry substrate. Determine impact of removal of interior wallboard finish on all courtroom walls to restore original design detailing.</p>	25 SF
WA.3

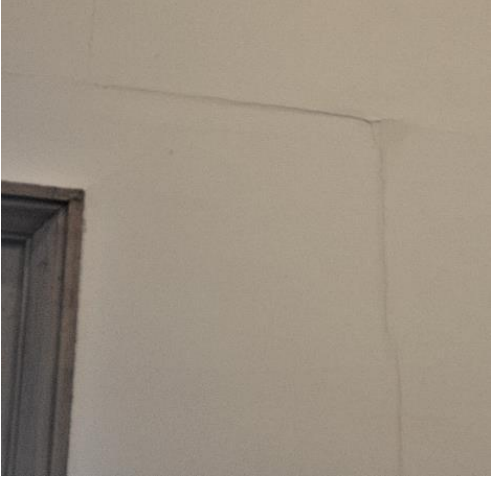
<p>Existing plaster board and plaster wall finish has gaps along joints and localized areas of deterioration.</p> <p>Repair damaged areas of wallboard and plaster finish. Paint 100% of walls. Alternate approach includes removal of all existing wall finish applied on top of historic plaster and repair/replacement of plaster wall finish.</p>	<p>6000 SF of painting / 150 SF of repairs</p> <p>Alternate: Remove applied wall board in courtroom and repair/replace plaster.</p>

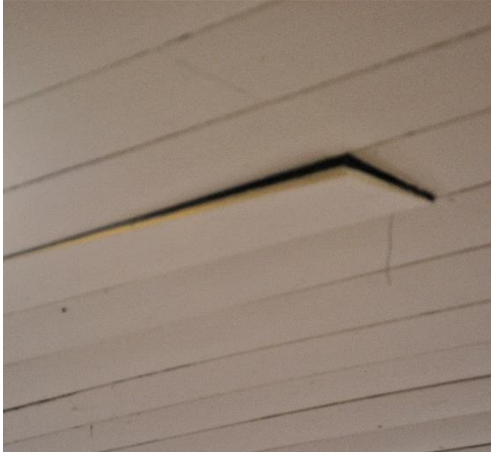
<p>The painted wood board ceiling exhibits minor finish deterioration and several boards have become unfastened over time.</p> <p>Refasten loose ceiling boards and cornice trim. Prepare and repaint 100% of painted wood board ceiling and cornice trim. Coordinate painting with paint analysis findings.</p>	1000 SF of repainting / Assume refastening of 15 ceiling/trim boards
CL.3

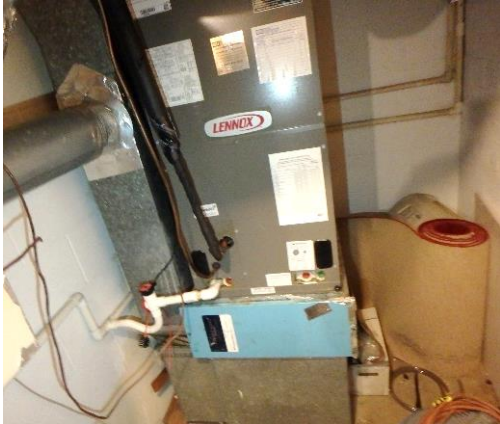
<p>Typical air handler setup (AH-1 shown) with air cleaner at return, condensate drain to pump unit.</p> <p>Regular servicing and tune-ups of all (4) systems are recommended twice annually at season changes.</p>	4 AHUs
M.2

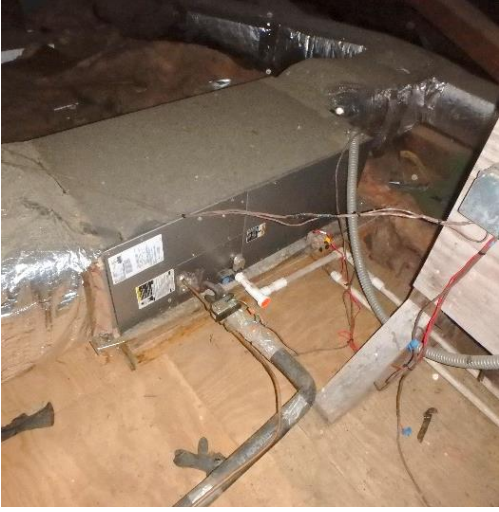
<p>No outside air intake duct exists at attic AHU-4.</p> <p>Provide new energy recovery unit (ERU) to supply pre-conditioned / room temperature-and-humidity neutral outside air to the courtroom when Jury Rooms 1 and/or 2 are occupied. Include automatic digital controls to insure the ERU operates when occupants are present. Estimated capacity of 300 CFM.</p>	<p>2 ERUs, controls, and 35 LF of ductwork</p>
M.6	 	<p>Heat recovery ventilator (HRV) in the mechanical room is no longer operational.</p> <p>Replace defunct HRV with a new energy recovery unit (ERU) to provide exhaust and pre-conditioned room temperature-and-humidity neutral outside air to the occupied spaces. Provide automatic digital controls to insure the new ERU operates when occupants are present. Estimated capacity of 300 CFM.</p>	<p>1 ERU</p>
M.7	 	<p>Basement bathroom exhaust fans are aged.</p> <p>Replace bathroom exhaust fan/lights in 1 existing operating bathroom. Determine potential for unused bathrooms to return to active use. If so, replace fans.</p>	<p>1 bathroom exhaust fan</p>

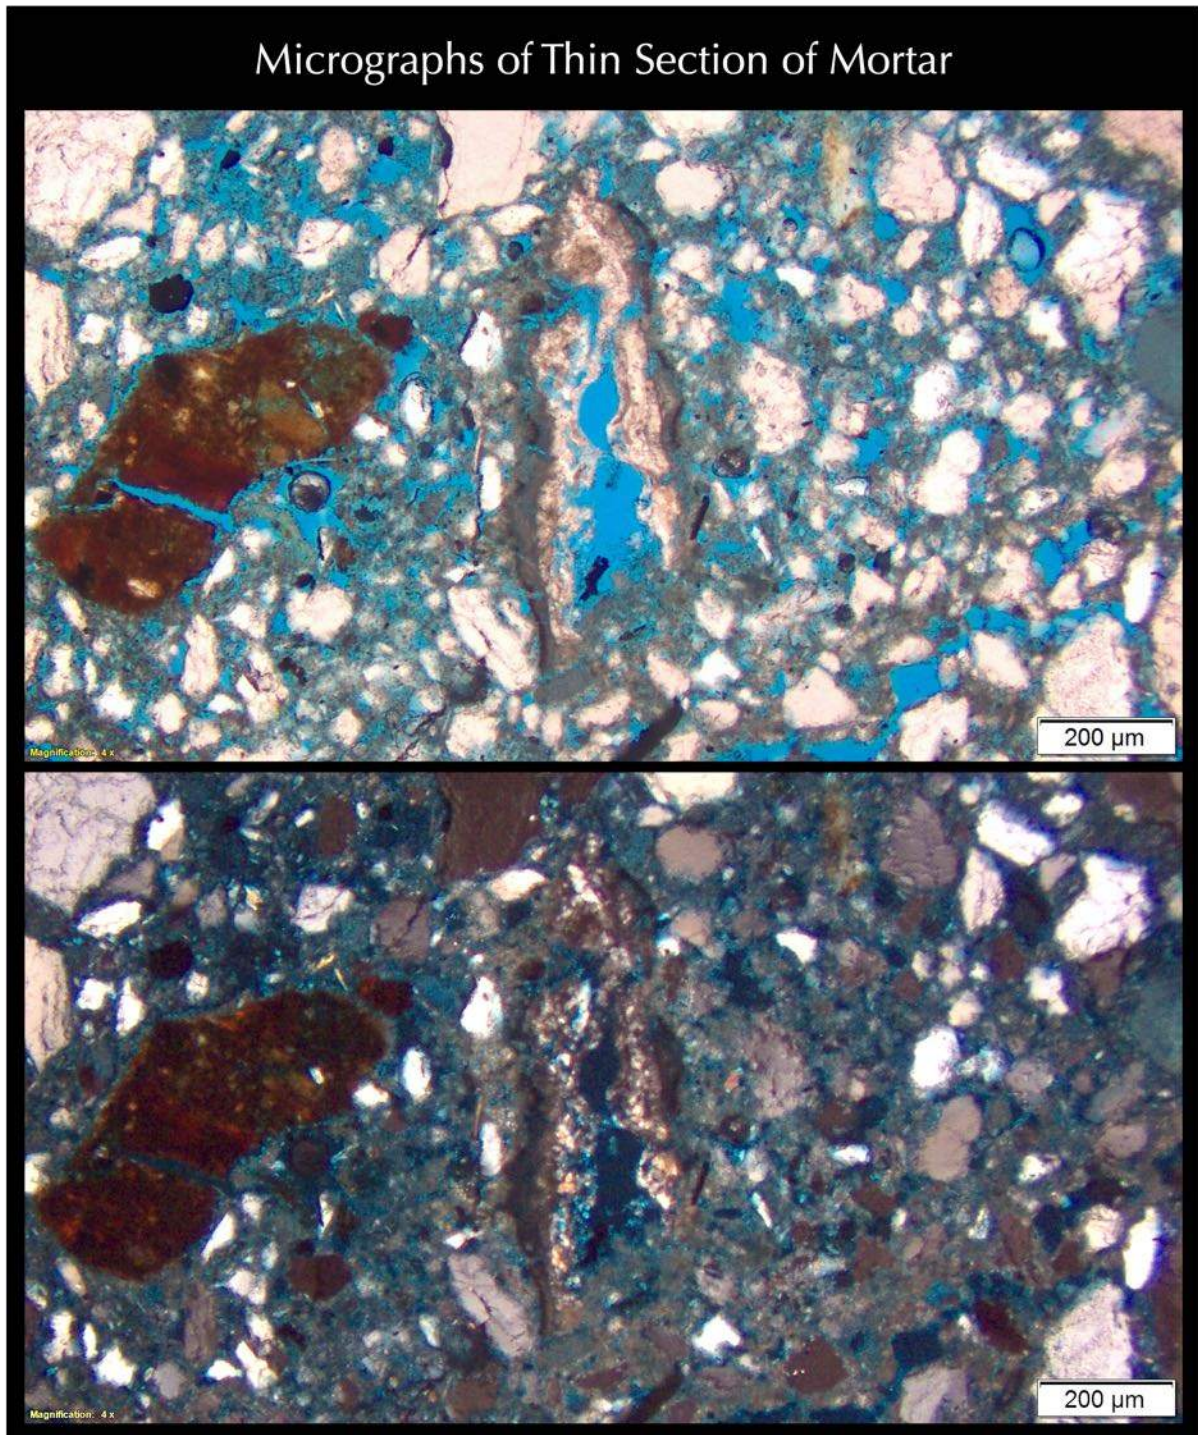
Figure 16: Micrographs of thin section of mortar showing: (a) very fine-grained, porous, carbonated to near-isotropic appearance of interstitial paste fraction; (b) subangular to subrounded, mostly equidimensional siliceous sand particles that are <1 mm in size, (c) some sheet-like flakes of mica and potential clay minerals, (d) a few lumps of unixed lime, which also shows a near-isotropic nature in XPL photo (bottom) as opposed to severely carbonated nature commonly found in lime lumps in many historic mortars, and (e) the non-air-entrained nature of mortar. A reddish brown ferruginous silicified wood contaminant is seen at the left and center. A few porous areas and microcracks are highlighted by blue epoxy in the top PPL photo.

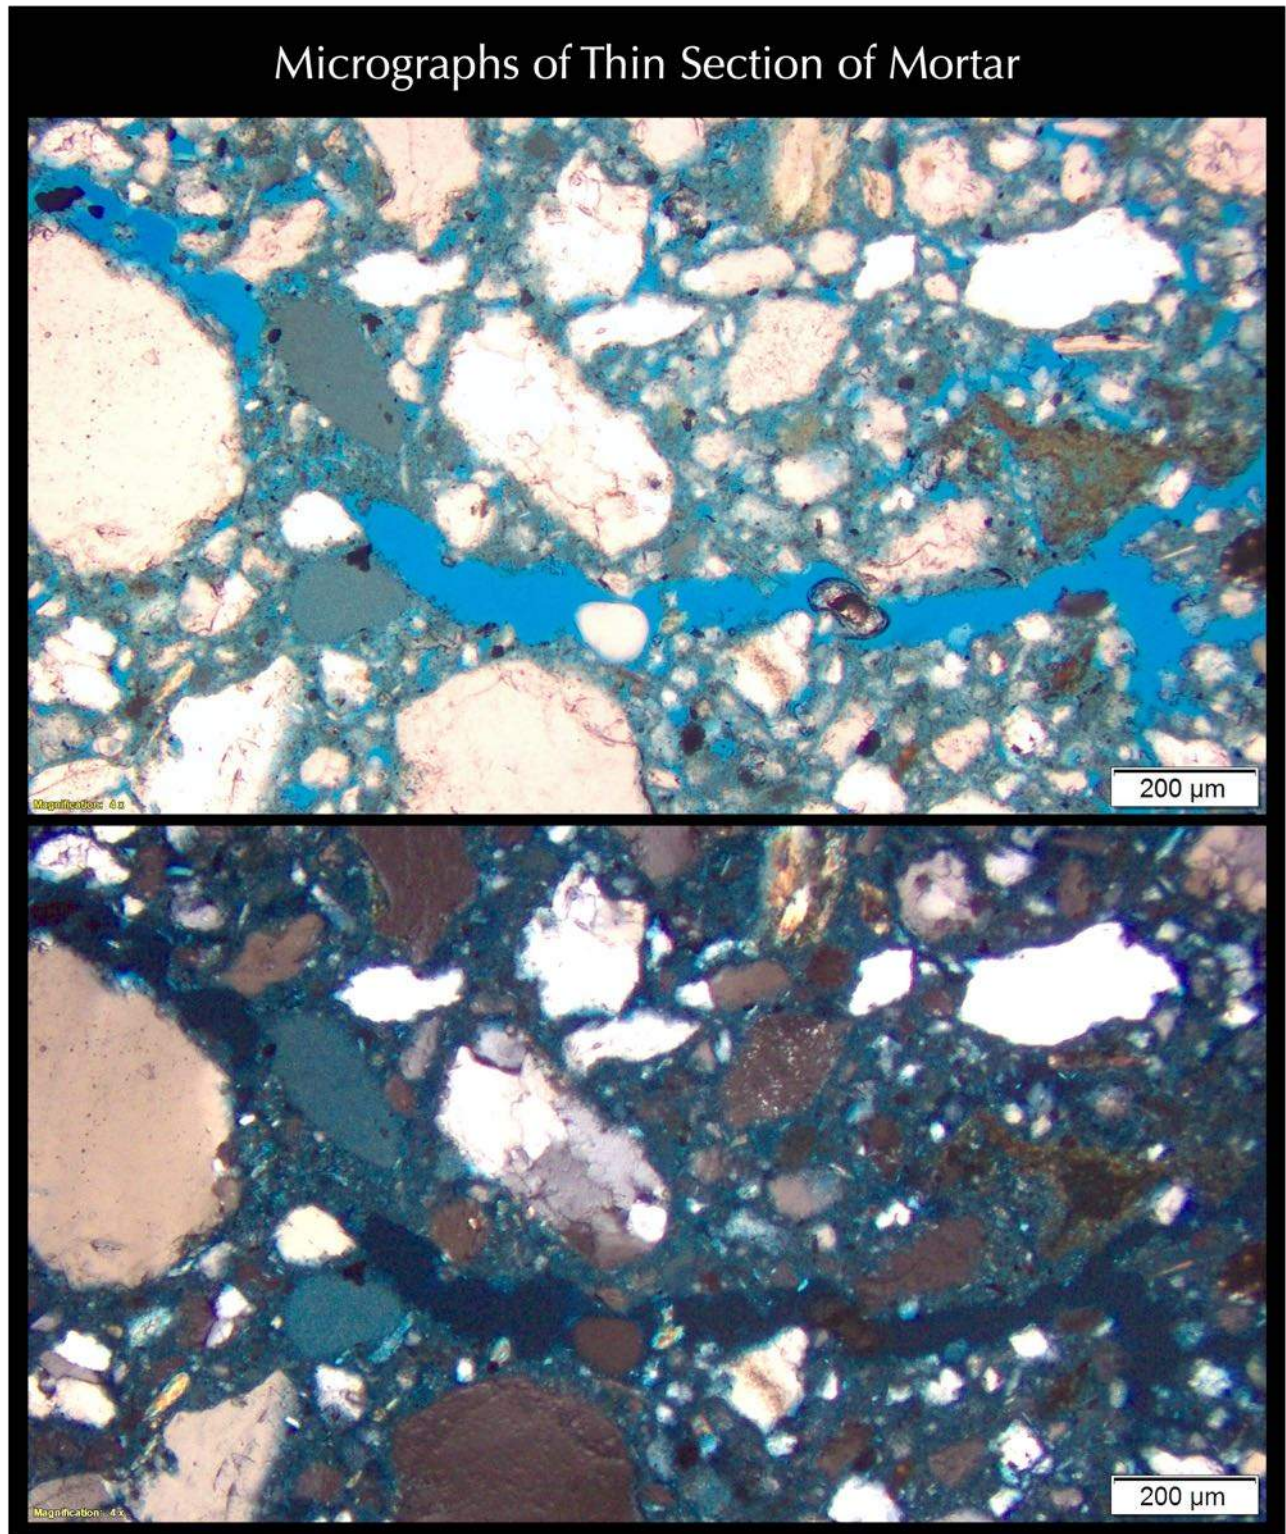
Figure 17: Micrographs of thin section of mortar showing: (a) very fine-grained, porous, carbonated to near-isotropic appearance of interstitial paste fraction; (b) subangular to subrounded, mostly equidimensional siliceous sand particles that are <1 mm in size, (c) some sheet-like flakes of mica and potential clay minerals, (d) a few lumps of unmixed lime, which also shows a near-isotropic nature in XPL photo (bottom) as opposed to severely carbonated nature commonly found in lime lumps in many historic mortars, and (e) the non-air-entrained nature of mortar. A microcrack is highlighted by blue epoxy in the top PPL photo.

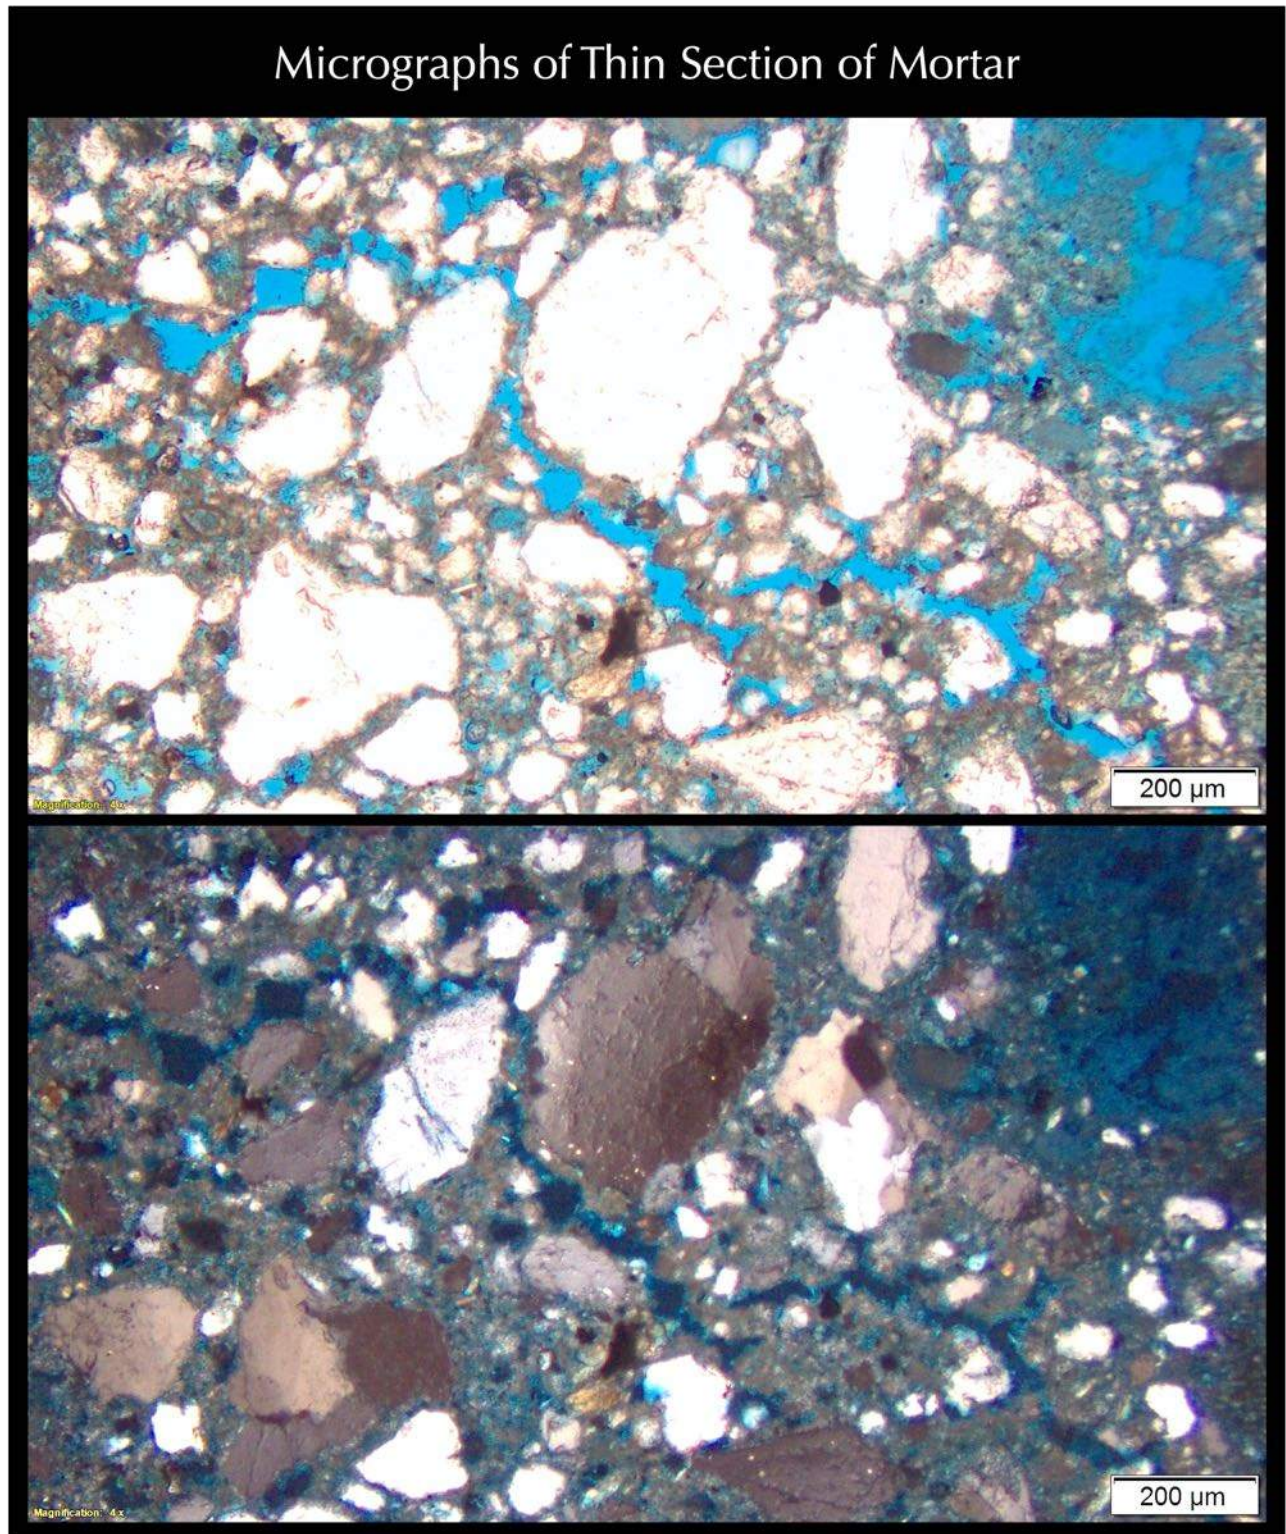
Figure 21: Micrographs of thin section of mortar showing: (a) very fine-grained, porous, carbonated to near-isotropic appearance of interstitial paste fraction; (b) subangular to subrounded, mostly equidimensional siliceous sand particles that are <1 mm in size, (c) some sheet-like flakes of mica and potential clay minerals, (d) a few lumps of unmixed lime, which also shows a near-isotropic nature in XPL photo (bottom) as opposed to severely carbonated nature commonly found in lime lumps in many historic mortars, and (e) the non-air-entrained nature of mortar. A few microcracks are highlighted by blue epoxy in the top PPL photo.

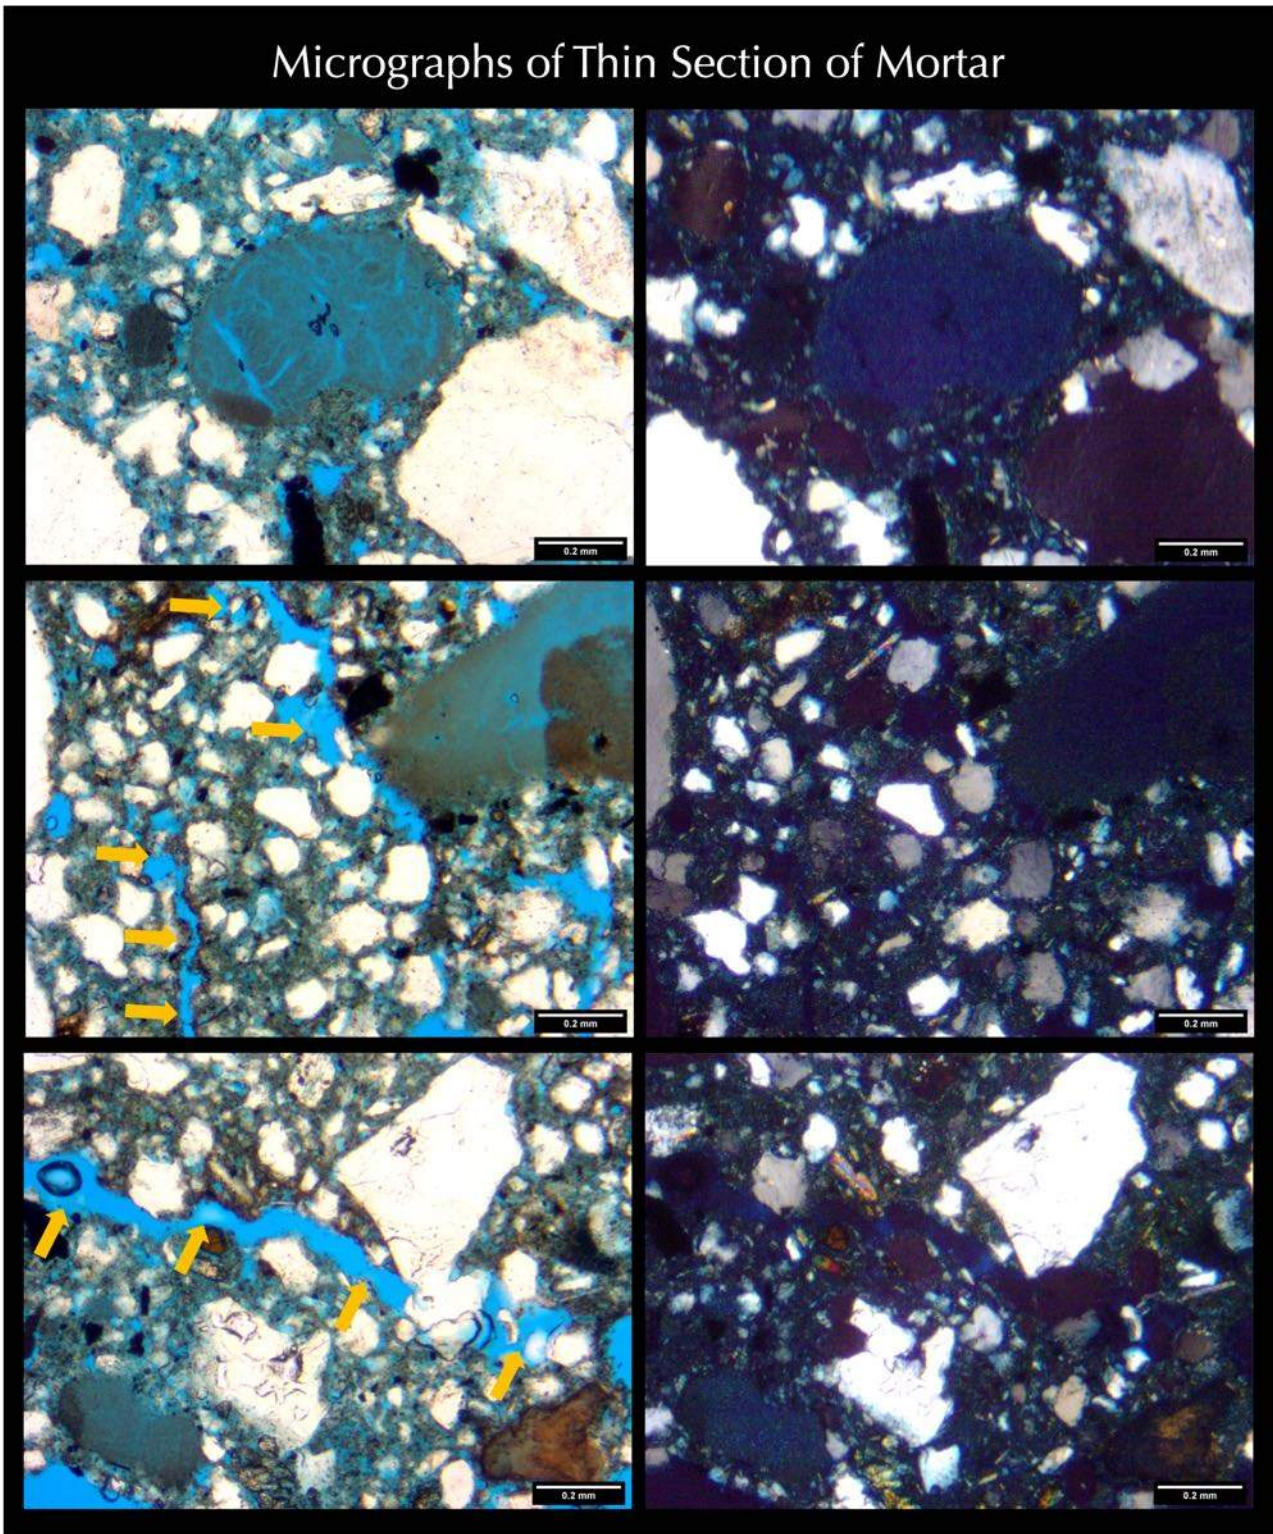
Figure 24: Micrographs of thin section of mortar showing: (a) very fine-grained, porous, mildly carbonated to near-isotropic appearance of interstitial paste fraction; (b) subangular to subrounded, mostly equidimensional siliceous sand particles that are <1 mm in size, (c) some sheet-like flakes of mica and potential clay minerals, (d) a few lumps of unmixed lime, which also shows a near-isotropic nature in XPL photo (bottom) as opposed to severely carbonated nature commonly found in lime lumps in many historic mortars, and (e) the non-air-entrained nature of mortar. A few microcracks are highlighted by arrows and blue epoxy in the middle and bottom left PPL photo.
