HISTORIC STRUCTURE REPORT  
FLUVANNA COUNTY HISTORIC COURTHOUSE  
COUNTY OF FLUVANNA, VIRGINIA

# FLUVANNA COUNTY HISTORIC COURTHOUSE

## HISTORIC STRUCTURE REPORT

September 7, 2022

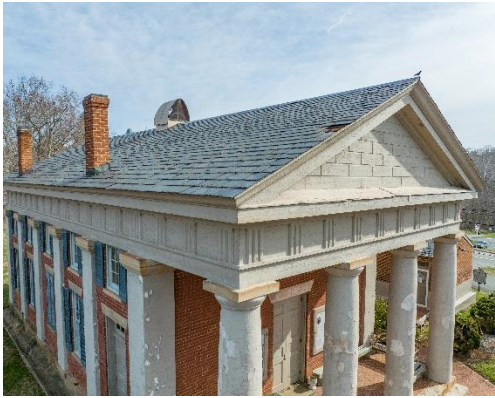
<p>The building does not currently have lightning protection and was recently damaged by an apparent lightning strike.</p> <p>Provide lightning protection system to mitigate potential for future damage.</p>	Full building lighting protection system

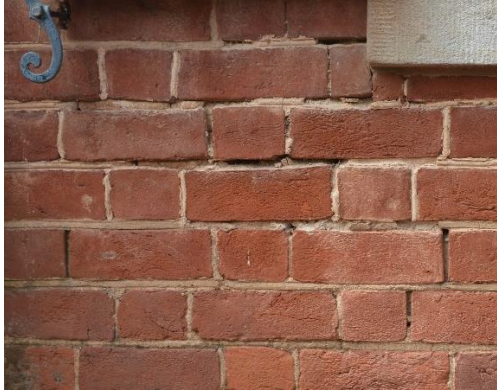
CODE	PHOTOGRAPH	CONDITION/REPAIR	QUANTITY
MB.1

<p>Open mortar joints and mortar deterioration occur on all elevations.</p> <p>Repoint open brick masonry joints with recommended mortar mixture using techniques to match original mortar joints. See further discussion in Key Issues section.</p>	125 SF
MB.2

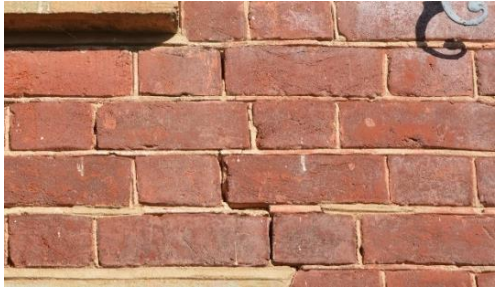
<p>Stairstep cracks occur in the mortar joints extending from the heads of many windows and door openings.</p> <p>Repoint localized areas identified on drawings, refer to MB.1 for repair and quantity.</p>	See MB.1
MB.3

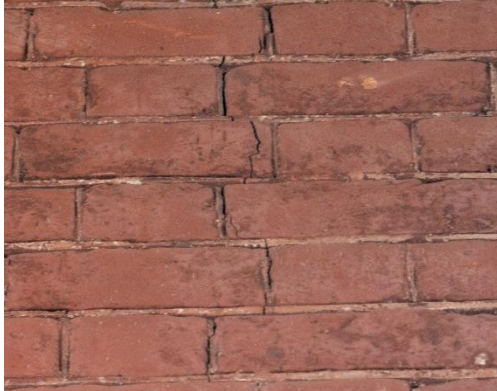
<p>Brick masonry units are cracked in several locations. This issue occurs with greatest frequency at the window lintel bearing points and near the south doors.</p> <p>Remove cracked brick unit. Provide matching brick unit and install in concert with wall repointing.</p>	8 brick units
MB.4

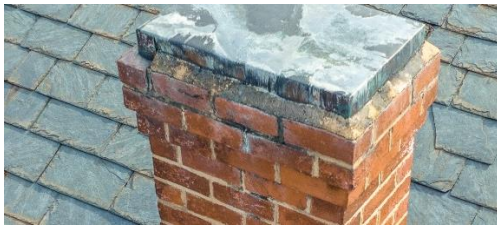
<p>Existing brick unit appears to be displaced from masonry assembly.</p> <p>Remove and reset displaced brick unit.</p>	1 brick unit

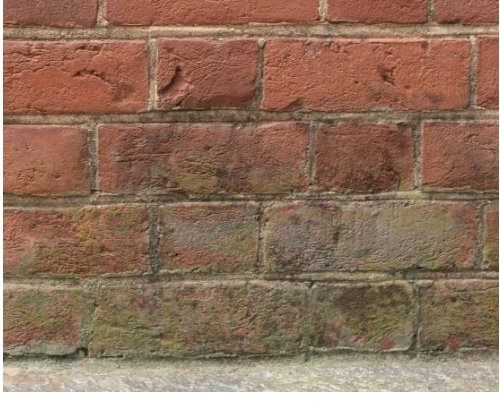
<p>MB.5</p>

<p>Biological growth is occurring at localized areas of the exterior masonry, typically along the base of the building, and causing staining on the exterior facade.</p> <p>Remove biological growth and staining with architectural anti-microbial biocide. Use gentlest means possible.</p> <p>400 SF</p>
<p>MB.6</p>

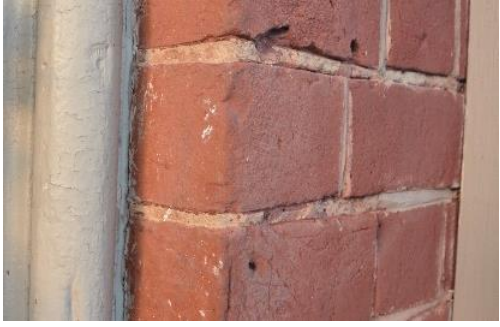
<p>There are holes in the brick masonry, apparently made by anchors in a small number of locations.</p> <p>Repair holes in masonry wall with compatible color-matched patching mortar.</p> <p>3 locations</p>
<p>MB.7</p>

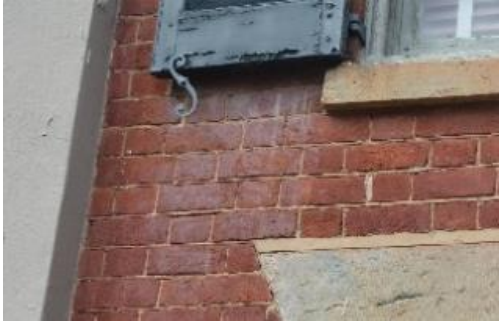
<p>Deteriorated paint from an adjacent painted surface has stained the masonry walls.</p> <p>Remove paint staining from surface of masonry walls. Perform tests on masonry and pursue the gentlest effective method.</p> <p>80 SF</p>
<p>MB.8</p>

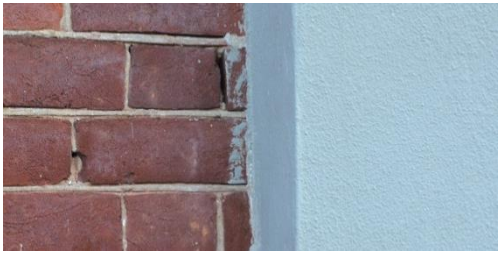
<p>Overpaint is present on masonry surfaces directly adjacent to painted surfaces.</p> <p>Remove overpaint on brick surfaces using the gentlest effective method.</p> <p>160 LF</p>

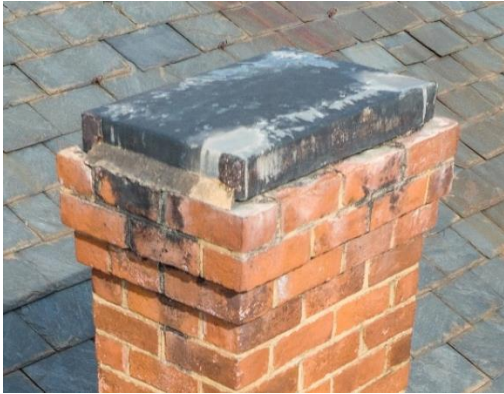
MB.12

<p>At top of existing chimney, the sloping mortar cap abuts the copper flue cap. This condition has led to deterioration of mortar.</p>	<p>4 locations @ 8 LF each</p>
MS.1	 	<p>Stone stairs at front portico display extensive mortar deterioration and numerous open joints.</p>	125 SF
MS.2

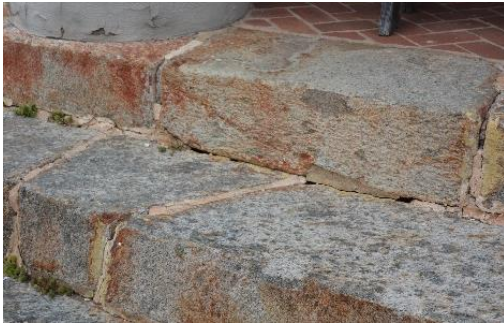
<p>Existing stone and concrete stairs display discoloration and staining.</p>	125 SF
MS.3

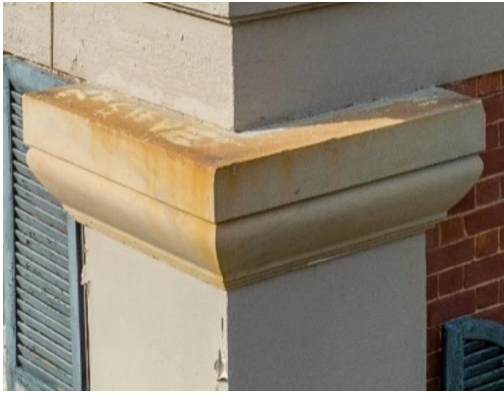
<p>The sky-facing sides of several of the stone capitals have graffiti and various surfaces are stained.</p>	18 locations
		<p>Remove paint and clean stains on stone capitals. Removal of all stains is not the intended goal. Clean surface with mild detergent and gentle water wash to remove surface dirt.</p>

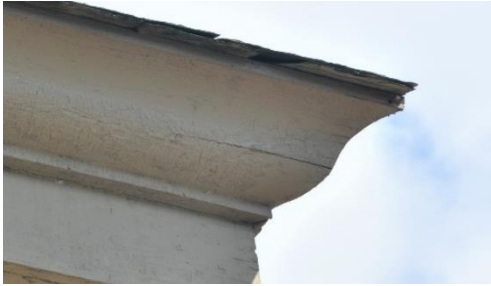
Existing wood cornice board has a split end.  Strip finish from damaged portion of wood cornice board. Remove rotted portions of wood and provide wood dutchman or epoxy repairs.	6 LF
WD.2

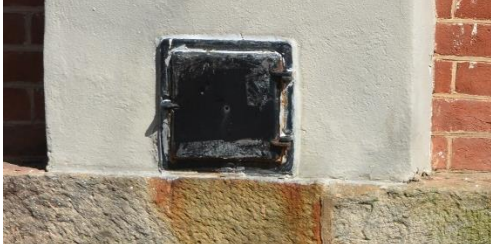
Existing metal access door displays deterioration.  Remove metal access door at pilaster. Provide new painted metal access door in existing opening.	1 location

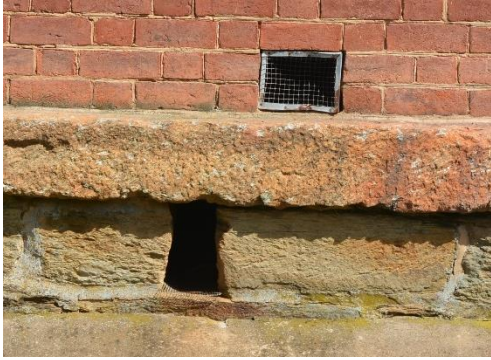
<p>The existing crawlspace vents have a series of mismatched screens which are in varied condition. Debris is entering crawlspace through vents.</p> <p>Remove metal screen. Provide new metal screen in existing opening set back from face of masonry.</p>	<p>10 locations</p>
<p>MT.4</p>

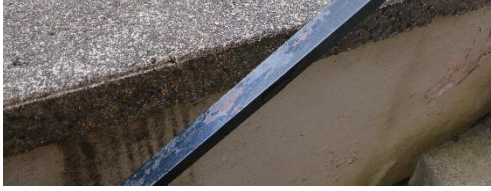
<p>Finish on existing metal railing is deteriorated.</p> <p>Prepare surface of metal handrail. Repaint.</p>	<p>2 locations @ 100 LF total</p>

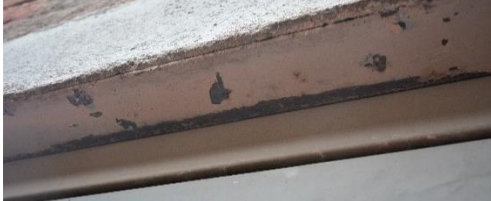
<p>MT.5</p>

<p>Existing metal element displays corrosion.</p> <p>Remove corrosion from surface of metal element. Repair surface deterioration. Paint.</p>	<p>4 LF</p>

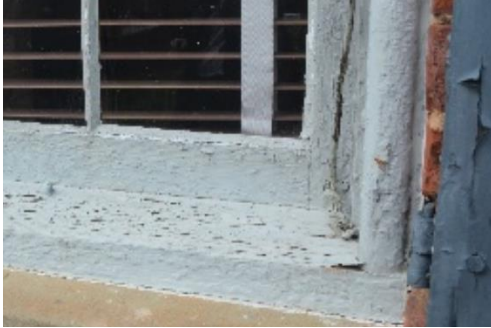
W.3

<p>Wiring is routed through a wood window sash.</p> <p>Assess need for wiring. Reroute wiring and repair hole at wood window sash.</p>	<p>1 location</p>

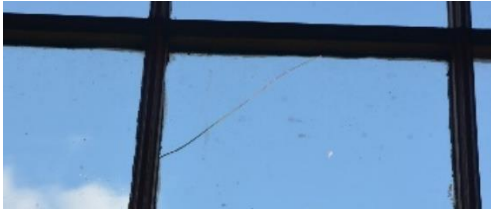
W.4

<p>Existing glass pane is broken.</p> <p>Remove cracked glass pane. Provide glass pane in existing window.</p>	1 location
-----	---	--	------------

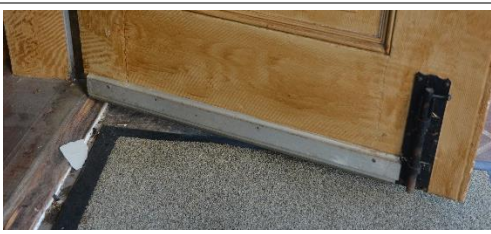
<p>Existing door sweep is damaged and beyond useful life.</p> <p>Remove and replace door sweep.</p>	3 paired doors
D.3

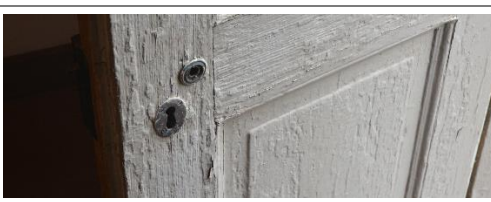
<p>Door is missing exterior knob.</p> <p>Restore door hardware and provide new door knob for existing hardware.</p>	1 location

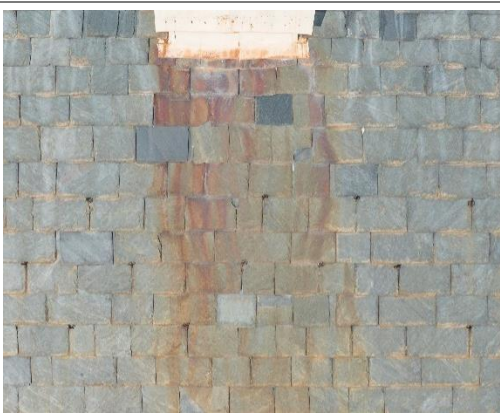
<p>Existing slate roof shingles are stained from corrosion at bell enclosure.</p> <p>Clean ferrous stains from slate shingles. Review cleaning methods. Complete tests to determine impact on adjacent fabric, including downstream surfaces, before full cleaning. Use gentlest effective method.</p>	200 SF

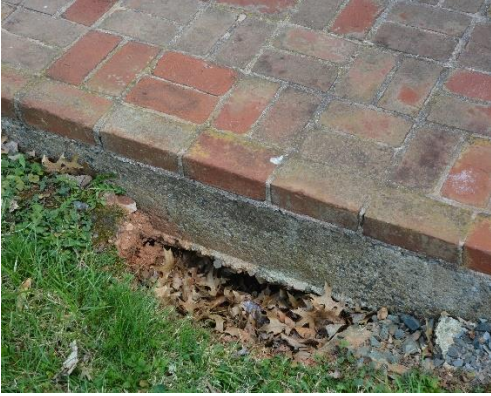
<p>Paving at north side of building has settled, opening a mortar joint and creating a hole adjacent to brick-paved walk.</p> <p>Repoint joint along building at walk. Monitor joint to determine if settlement is active. Provide compacted fill to create level surface up to existing brick paving.</p>	1 instance @ 8 SF
O.2

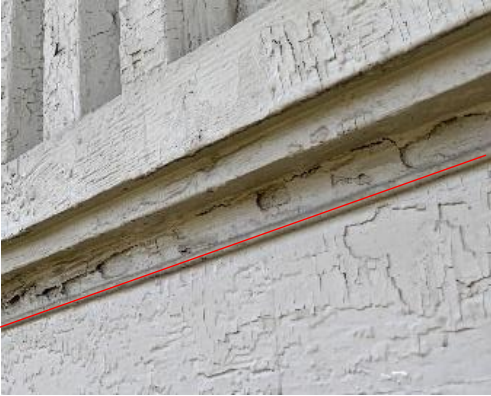
<p>Various types of wiring are mounted to the exterior face of the building. See red highlight line for reference.</p> <p>Determine if wiring is in active service. Reroute surface wiring and remove mounting accessories. Repair surface as necessary. Provide concealed interior wiring.</p>	2 instances
O.3

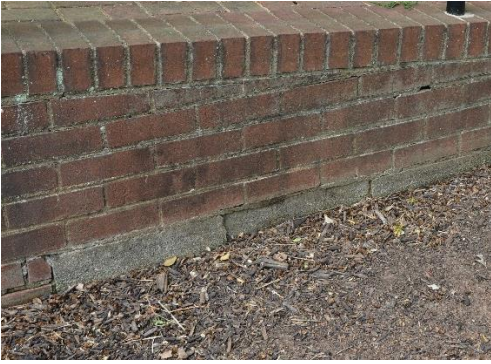
<p>The exterior grade has settled at the face of masonry accessible ramp, revealing the concrete block foundation wall.</p> <p>Regrade planting bed at brick ramp to obscure concrete block foundation wall and create positive slope away from building.</p>	1 location of approx. 40 SF

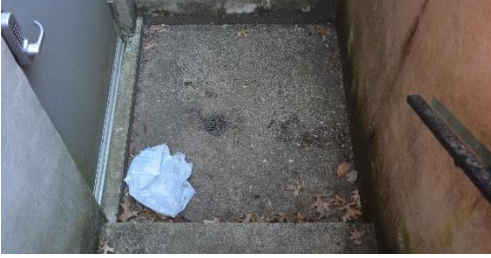
O.4

<p>Debris has collected in basement areaway and soiling has occurred on the stair retaining walls.</p> <p>Clean areaway and basement stair of all dirt and debris.</p>	60 SF

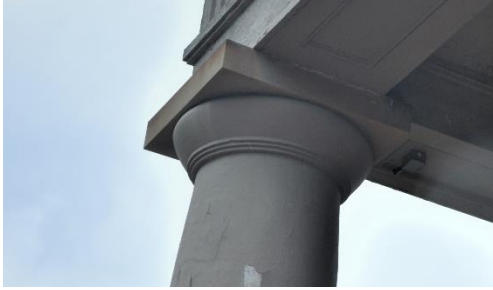
O.5

There is a bird nest on the horizontal surface of a column capital.

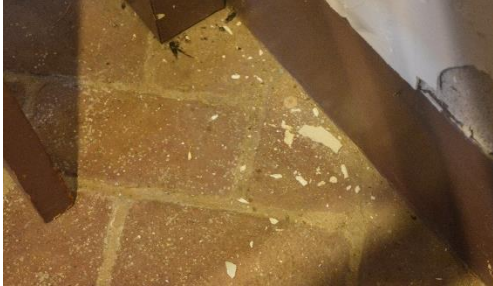
The interior of the building has a minor extent of debris and soiling throughout, especially the basement and upper levels.  Clean all interior spaces to remove debris and soiling.	2,500 SF
GI.2

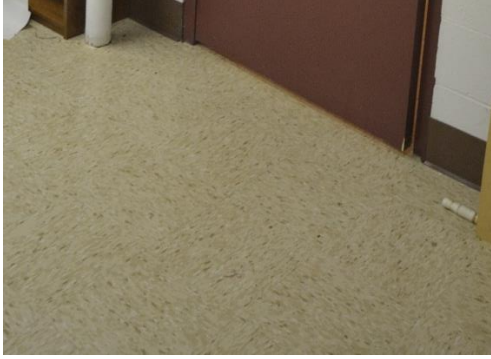
F.2

<p>Existing vinyl composition tile (VCT) flooring displays minor discoloration due to age. Despite discoloration, floor tile is in good condition.</p>	780 SF
		<p>As basement is expected to remain back-of-house space, maintain existing flooring and apply protective coating.</p>	
F.3

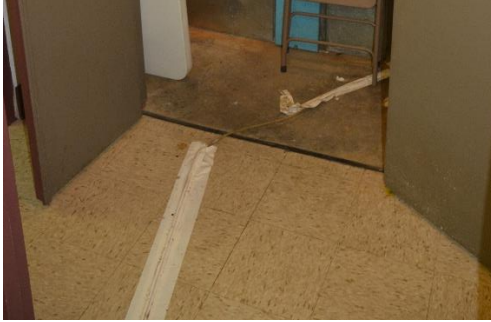
<p>Dehumidifier drain line is taped to floor from registrar's storage room to floor drain in mechanical room.</p>	1 location at 6 LF
		<p>Provide heavy duty protector for condensate line until mechanical upgrades are completed in basement.</p>	
F.4

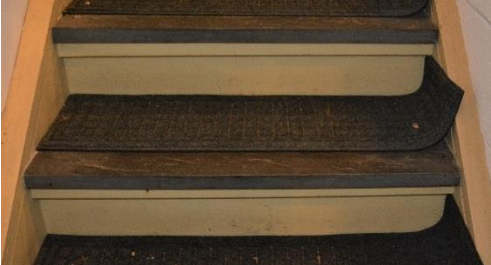
F.5

<p>Stair tread covers do not fit the width of the basement stair treads.</p>	20 LF
		<p>Provide broadloom carpet stair runner down center of stair.</p>

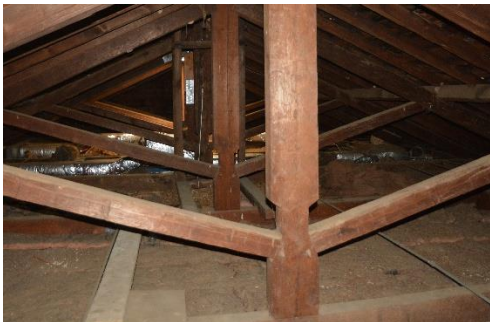
F.9

<p>Attic lacks a walking surface to permit maintenance access across length.</p> <p>Install 4'-0" wide by 3/4" thick plywood decking on existing ceiling joists to create maintenance access path to full length of attic.</p>	<p>200 SF</p>

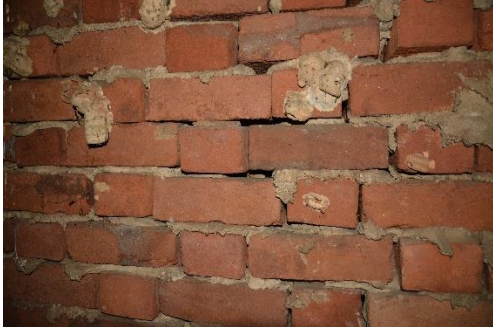
<p>Interior face of brick tympanum on north wall exhibits extensive deterioration of mortar joints and brick displacement.</p> <p>Repoint 100% of interior side of brick tympanum with recommended mortar mixture. Reset displaced brick units.</p>	100 SF
WA.6

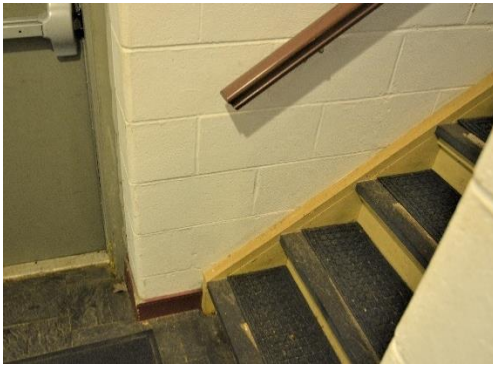
<p>The basement stair handrail does not meet code due to low mounting height and lack of extension at bottom landing.</p> <p>Remove and replace existing basement stair handrail. Relocate light switches at basement landing to accommodate raised handrail.</p>	1 location
WA.7

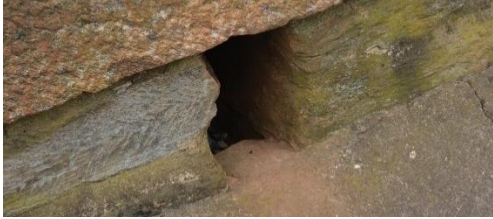
<p>Debris is entering crawlspace area through exterior vents.</p> <p>Remove wall-mounted vents and fans. Inspect crawlspace. Remove debris. Provide vents.</p>	5 locations
WA.8	 	<p>Wood paneling at gallery beam is cracked and displays rot.</p> <p>Remove approximately 30" long portion of deteriorated wood paneling and pulley at gallery support beam. Remove wood paneling members in their entirety back to nearest joint. Do not cut wood to remove. Examine substrate to determine extent of damage. Remove any areas of wood rot and repair surface damage with epoxy. Reinstall paneling. Paint.</p>	5 SF

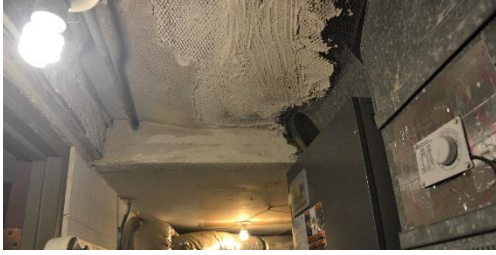
<p>The basement mechanical room ceiling is damaged.</p> <p>Remove damaged metal lath and plaster in mechanical closet. Provide new ceiling in entire mechanical closet.</p>	40 SF
CL.2

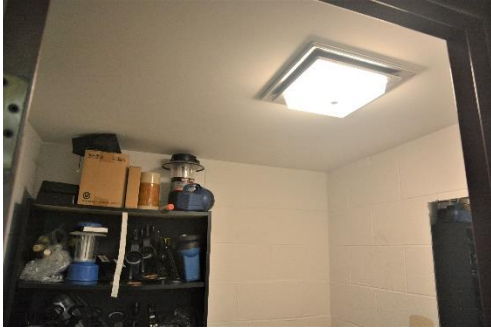
<p>Localized areas of gypsum wallboard ceiling display minor finish deterioration.</p> <p>Patch damaged area of gypsum wallboard ceiling. Prepare and paint 100% of gypsum ceiling.</p>	750 SF of painting / 20 SF of repairs
CL.4

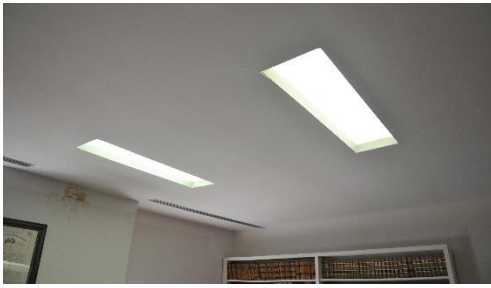
<p>Localized areas of plaster ceiling display minor finish deterioration.</p> <p>Prepare and paint 100% of plaster ceiling. Perform work in concert with plaster repairs in item CL.5.</p>	950 SF

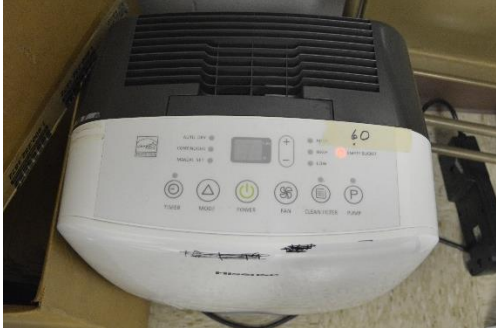
<p>Several dehumidifiers indicate that the buckets are full and require emptying.</p>	<p>6 units</p>
<p>Until mechanical system upgrades occur, a routine maintenance schedule should be developed for the basement dehumidifiers.</p>

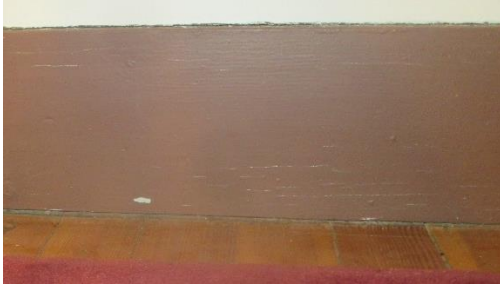
Settlement has occurred at the second-floor gallery evidenced by the small gap at the shoe molding and the floor.  Monitor gap at floor and base trim over time to determine if settlement is active.	N/A
S.2

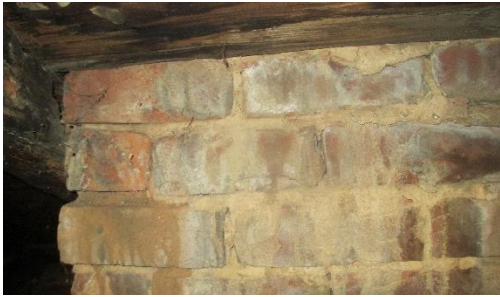
The mortar at the chimneys in the attic displays extensive deterioration.  Repoint 100% of three chimneys in attic.	30 SF
S.3

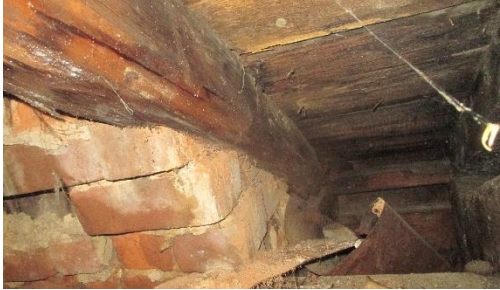
The roof rafters notched into the chimneys have rotted extensively at three of the four chimneys.  Remove rotted wood and sister new member onto sound portions of existing member.	2 instances at 3 chimneys
S.4

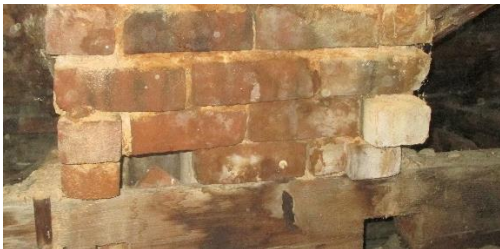
Brick is missing at chimney in attic.  Install salvaged brick in missing location. Coordinate with chimney repointing.	1 instance
S.5

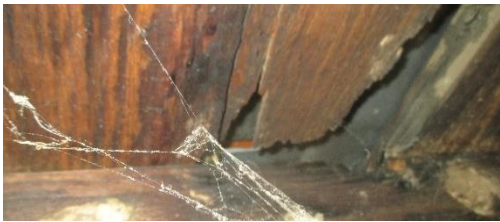
Roof sheathing is rotted due to water infiltration.  Replace rotted areas of wood. Coordinate repairs with roofing repairs.	25 SF

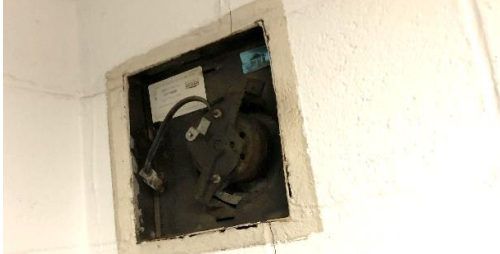
<p>Basement wall exhaust fans are of dated vintage and do not appear to be operative.</p> <p>Replace fans, wall switches, and existing open-ended outside air intake duct.</p>	3 wall exhaust fans, 3 switches, and 15 LF of ductwork
M.3

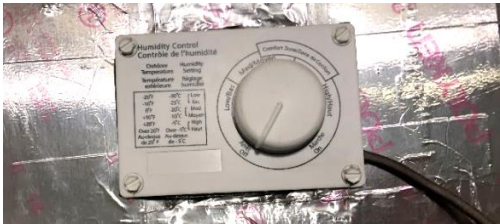
<p>Basement has build-up of humidity.</p> <p>Test all humidifiers and associated controls to confirm proper operation.</p>	3 total
M.4

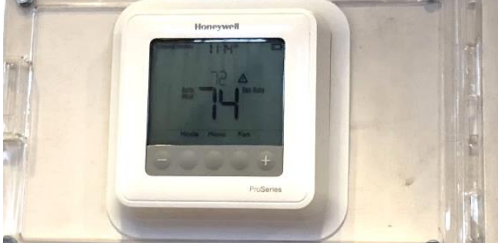
<p>Existing thermostats require calibration.</p> <p>Calibrate existing thermostats to confirm accurate operation and ability to maintain desired indoor temperature conditions.</p>	4 total

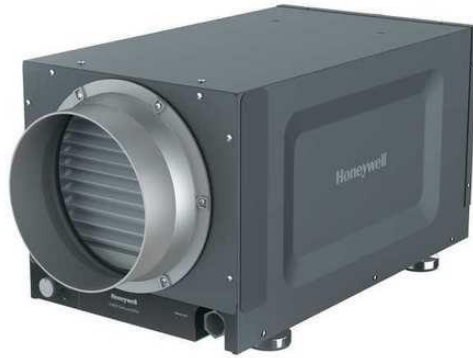
M.8

Basement humidity levels are excessive and damaging to paper documents. Portable dehumidifiers appear to be ineffective for mitigating this problem.

Install a ducted dehumidifier and associated interior ductwork to serve the Basement level. This also may require an exhaust fan to remove the heat generated by the dehumidifier.

Provide 1 dehumidifier, humidistat with return/supply ductwork; 1 exhaust fan, associated exhaust duct and exterior louver

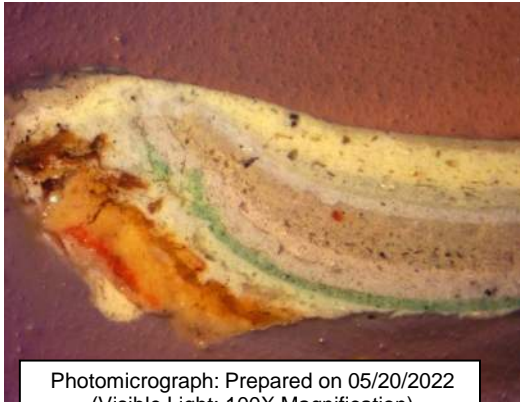
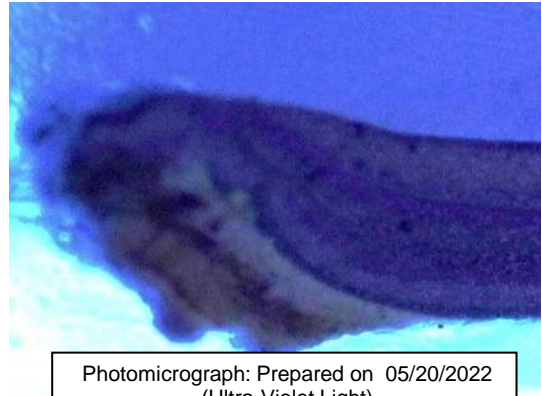
**Comments:** This sample shows a different color scheme that seems to predate the white scheme found in other samples. This sample in combination with FP03 and FP09 suggests the doors may have had a varnished faux-grained scheme at some point. The doors have a different paint stratigraphy than the wood trim. Exposure windows in the paint may confirm/reveal what the graining looked like. This scheme is identified as "Scheme 1".

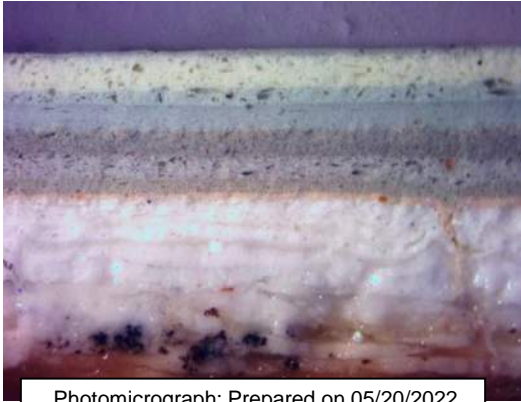
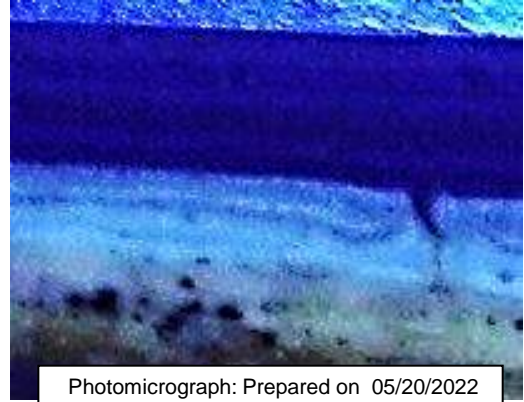
**Comments:** This sample shows some degradation of the finish just above the wood which perhaps indicates the previous finish was sanded or removed. The many layers of white confirm "Scheme 2" in the color chart.

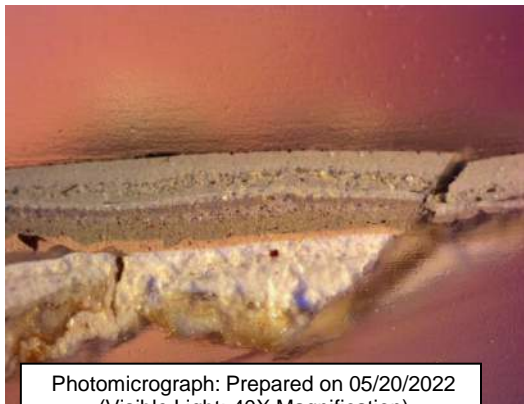
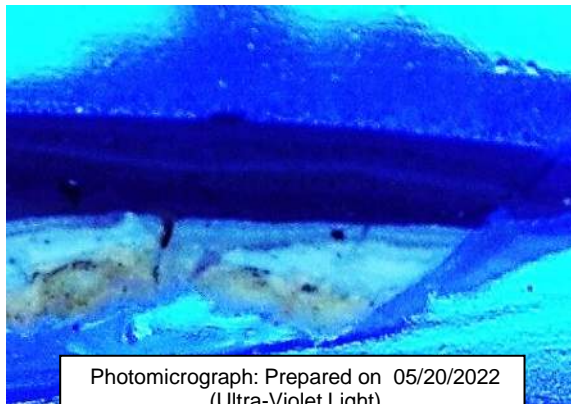
<b>Project:</b>	Fluvanna Courthouse		
<b>Building Name:</b>	Courthouse	<b>Location of Building:</b>	Fluvanna, VA
<b>Sample Number:</b>	FP-11	<b>Element Type:</b>	Window Frame Bead
<b>Location of Sample:</b>	West Elevation

**Comments:** The layers of grayish white paint followed by a thin layer of moderate yellowish pink is a benchmark sequence found in most of the samples. We do not have an exact timeline of schemes but we know the wood trim and doors were painted white in the early 20th century from photographs. The multiple layers suggest the trim was painted white for a number of years. We have identified this series as "Scheme 2" in our color chart. The UV glow of the white paints suggest oil binders.

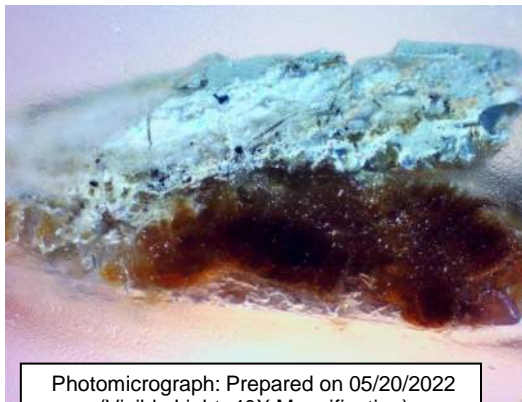
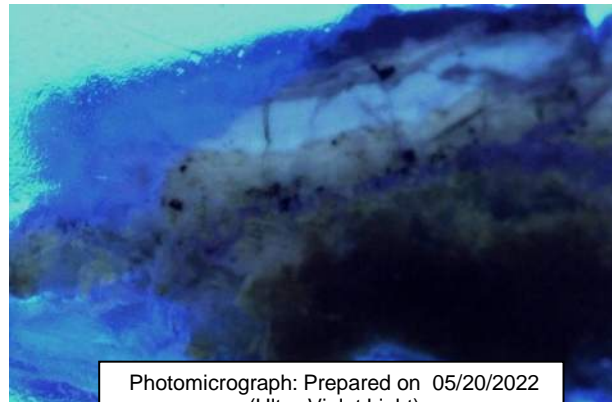
<b>Project:</b>	Fluvanna Courthouse		
<b>Building Name:</b>	Courthouse	<b>Location of Building:</b>	Fluvanna, VA
<b>Sample Number:</b>	FP-14	<b>Element Type:</b>	Window Frame Bead
<b>Location of Sample:</b>	North Elevation

**Comments:** The layers of grayish white paint followed by a thin layer of moderate yellowish pink is a benchmark sequence found in most of the samples. We do not have an exact timeline of schemes but we know the wood trim and doors were painted white in the early 20th century from photographs. The multiple layers suggest the trim was painted white for a number of years. We have identified this series as "Scheme 2" in our color chart. The UV glow of the white paints suggest oil binders.

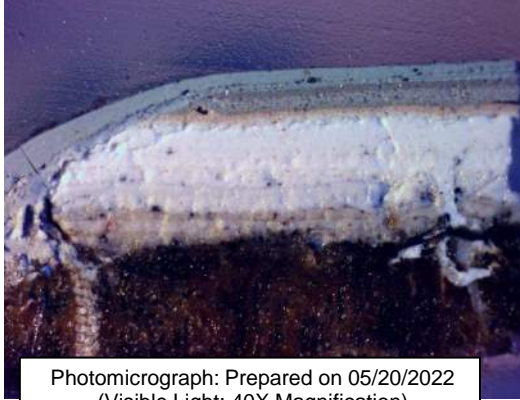
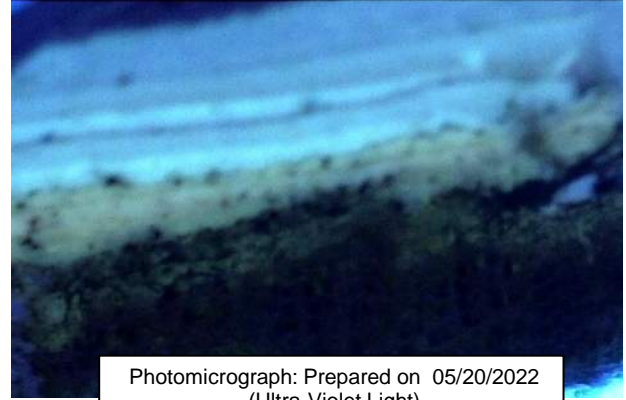
**Comments:** The layers of grayish white paint followed by a thin layer of moderate yellowish pink is a benchmark sequence found in most of the samples. We do not have an exact timeline of schemes but we know the wood trim and doors were painted white in the early 20th century from photographs. The multiple layers suggest the trim was painted white for a number of years. We have identified this series as "Scheme 2" in our color chart. The UV glow of the white paints suggest oil binders.

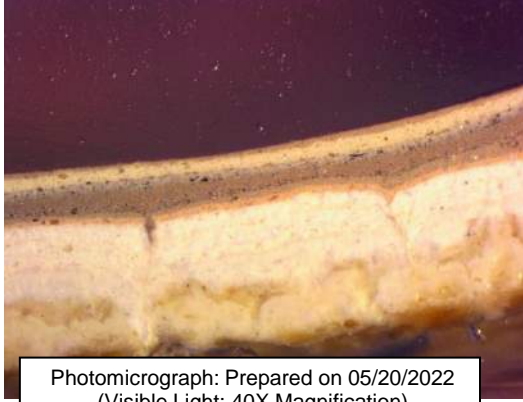
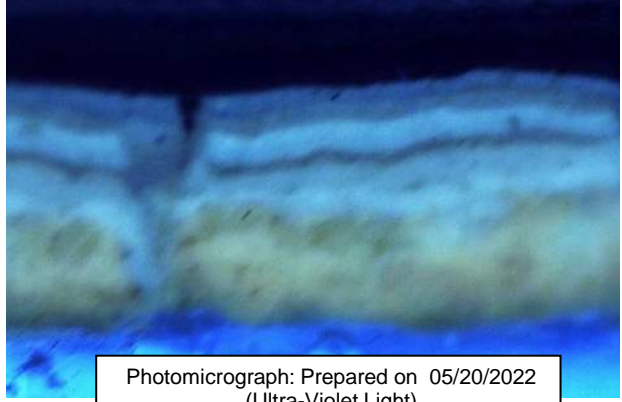
<b>Project:</b>	Fluvanna Courthouse		
<b>Building Name:</b>	Courthouse	<b>Location of Building:</b>	Fluvanna, VA
<b>Sample Number:</b>	FP-18	<b>Element Type:</b>	Entablature
<b>Location of Sample:</b>	East Elevation

**Comments:** The layers of grayish white paint followed by a thin layer of moderate yellowish pink is a benchmark sequence found in most of the samples. We do not have an exact timeline of schemes but we know the wood trim and doors were painted white in the early 20th century from photographs. The multiple layers suggest the trim was painted white for a number of years. We have identified this series as "Scheme 2" in our color chart. The UV glow of the white paints suggest oil binders.

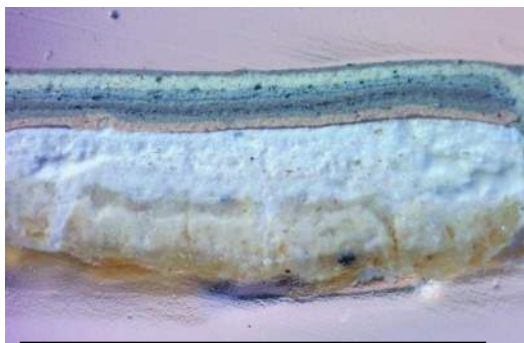
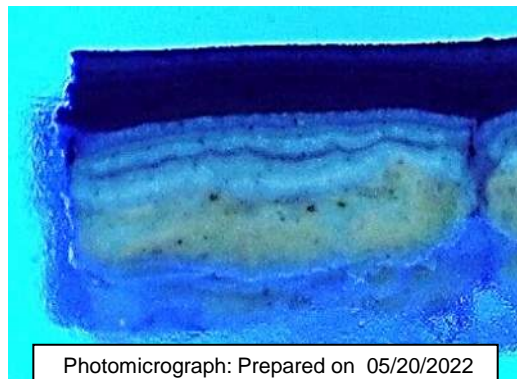
<b>Project:</b>	Fluvanna Courthouse		
<b>Building Name:</b>	Courthouse	<b>Location of Building:</b>	Fluvanna, VA
<b>Sample Number:</b>	FP-19	<b>Element Type:</b>	Entablature Metope
<b>Location of Sample:</b>	East Elevation

**Comments:** The layers of grayish white paint followed by a thin layer of moderate yellowish pink is a benchmark sequence found in most of the samples. We do not have an exact timeline of schemes but we know the wood trim and doors were painted white in the early 20th century from photographs. The multiple layers suggest the trim was painted white for a number of years. We have identified this series as "Scheme 2" in our color chart. The UV glow of the white paints suggest oil binders.

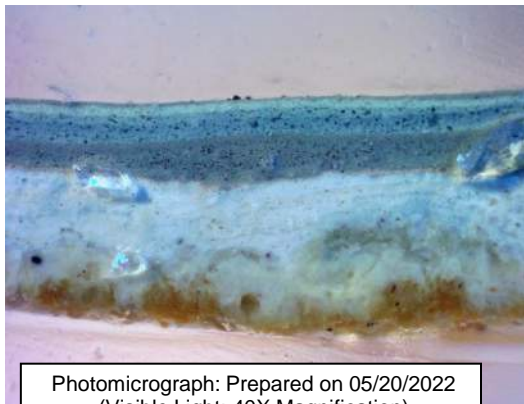
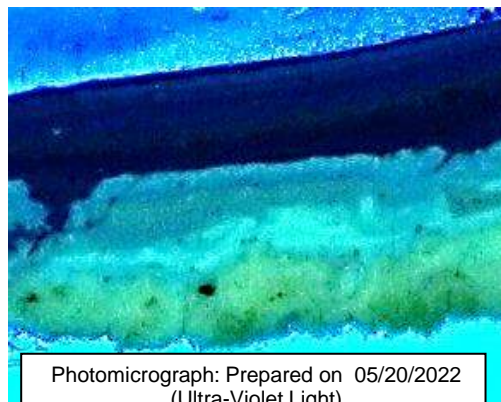
<b>Project:</b>	Fluvanna Courthouse		
<b>Building Name:</b>	Courthouse	<b>Location of Building:</b>	Fluvanna, VA
<b>Sample Number:</b>	FP-20	<b>Element Type:</b>	Entablature Triglyph
<b>Location of Sample:</b>	East Elevation

**Comments:** The layers of grayish white paint followed by a thin layer of moderate yellowish pink is a benchmark sequence found in most of the samples. We do not have an exact timeline of schemes but we know the wood trim and doors were painted white in the early 20th century from photographs. The multiple layers suggest the trim was painted white for a number of years. We have identified this series as "Scheme 2" in our color chart. The UV glow of the white paints suggest oil binders.

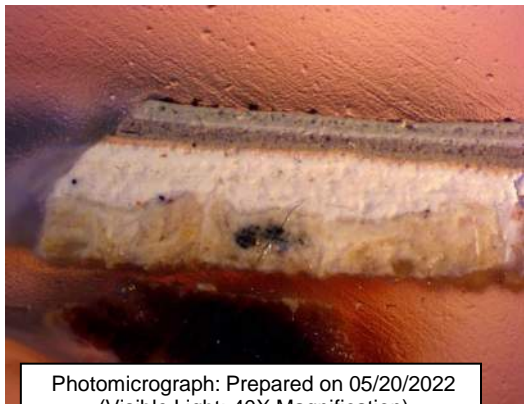
<b>Project:</b>	Fluvanna Courthouse		
<b>Building Name:</b>	Courthouse	<b>Location of Building:</b>	Fluvanna, VA
<b>Sample Number:</b>	FP-21	<b>Element Type:</b>	Upper Window Frame
<b>Location of Sample:</b>	East Elevation

**Comments:** The layers of grayish white paint followed by a thin layer of moderate yellowish pink is a benchmark sequence found in most of the samples. We do not have an exact timeline of schemes but we know the wood trim and doors were painted white in the early 20th century from photographs. The multiple layers suggest the trim was painted white for a number of years. We have identified this series as "Scheme 2" in our color chart. The UV glow of the white paints suggest oil binders.

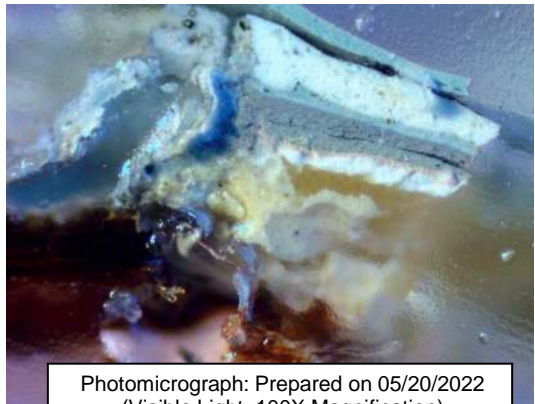
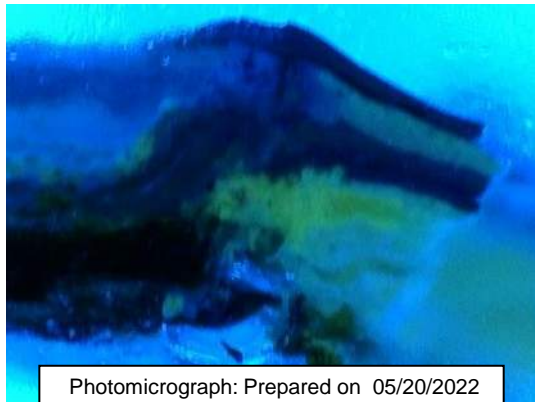
<b>Project:</b>	Fluvanna Courthouse		
<b>Building Name:</b>	Courthouse	<b>Location of Building:</b>	Fluvanna, VA
<b>Sample Number:</b>	FP-22	<b>Element Type:</b>	Upper Window Sash
<b>Location of Sample:</b>	East Elevation

**Comments:** The layers of grayish white paint followed by a thin layer of moderate yellowish pink is a benchmark sequence found in most of the samples. We do not have an exact timeline of schemes but we know the wood trim and doors were painted white in the early 20th century from photographs. The multiple layers suggest the trim was painted white for a number of years. We have identified this series as "Scheme 2" in our color chart. The UV glow of the white paints suggest oil binders.

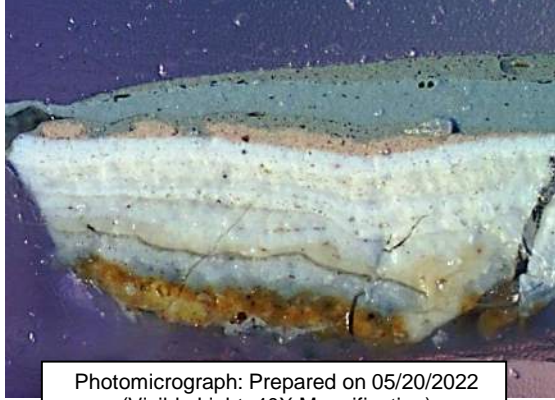
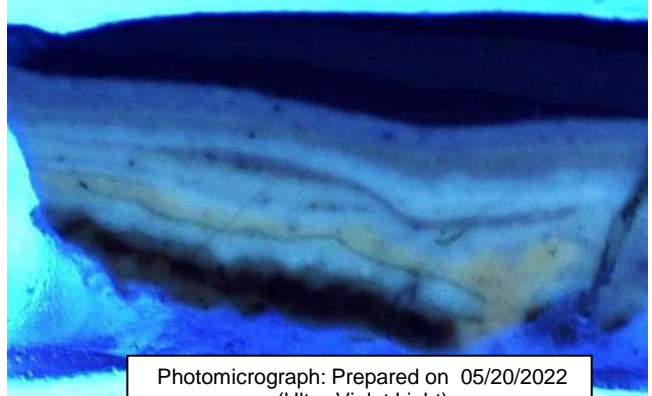
<b>Project:</b>	Fluvanna Courthouse		
<b>Building Name:</b>	Courthouse	<b>Location of Building:</b>	Fluvanna, VA
<b>Sample Number:</b>	FP-25	<b>Element Type:</b>	Door Stile
<b>Location of Sample:</b>	West Elevation

**Comments:** This sample has some of the early yellows and potential faux-grain identified as "Scheme 1." The blue layer is an outlier from all the samples and may represent an anomaly or a degradation of a white layer. The layers of grayish white paint followed by a thin layer of moderate yellowish pink is a benchmark sequence found in most of the samples. We do not have an exact timeline of schemes but we know the wood trim and doors were painted white in the early 20th century from photographs. The multiple layers suggest the trim was painted white for a number of years. We have identified this series as "Scheme 2" in our color chart. The UV glow of the white paints suggest oil binders.

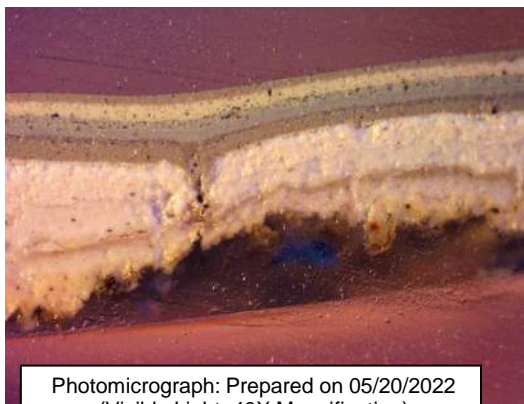
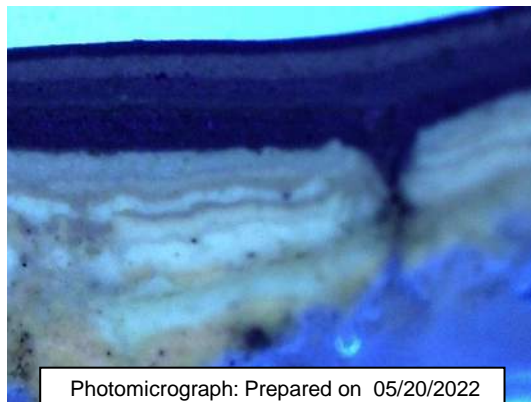
**Element Type:** Transom Sash

**Comments:** This sample has some of the early yellows and potential faux-grain identified as "Scheme 1." The layers of grayish white paint is missing the thin layer of moderate yellowish pink that was part of the benchmark sequence found in most of the samples. We do not have an exact timeline of schemes but we know the wood trim and doors were painted white in the early 20th century from photographs. The multiple layers suggest the trim was painted white for a number of years. We have identified this series as "Scheme 2" in our color chart. The UV glow of the white paints suggest oil binders.

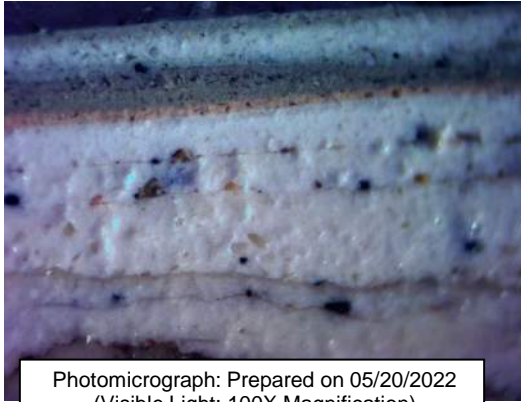
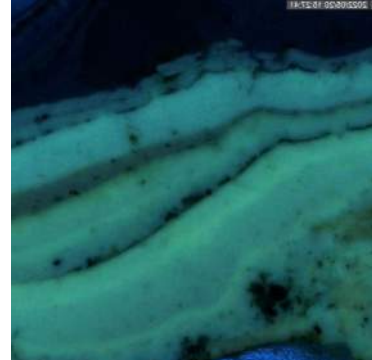
**Element Type:** Soffit Frame

**Comments:** The layers of grayish white paint followed by a thin layer of moderate yellowish pink is a benchmark sequence found in most of the samples. We do not have an exact timeline of schemes but we know the wood trim and doors were painted white in the early 20th century from photographs. The multiple layers suggest the trim was painted white for a number of years. We have identified this series as "Scheme 2" in our color chart. The UV glow of the white paints suggest oil binders.

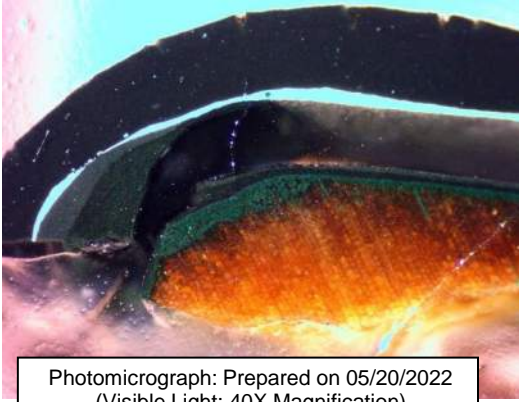
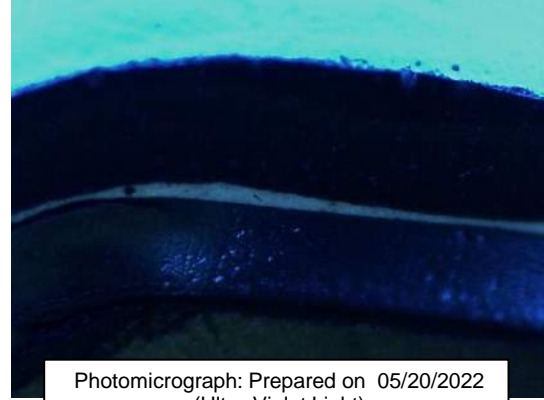
**Element Type:** Window Shutter

**Comments:** Most of the paint layers in the sample lay flat suggesting modern paints. This sample confirms that the shutters have been painted green for a long period of time but does not provide information about earlier paint colors.

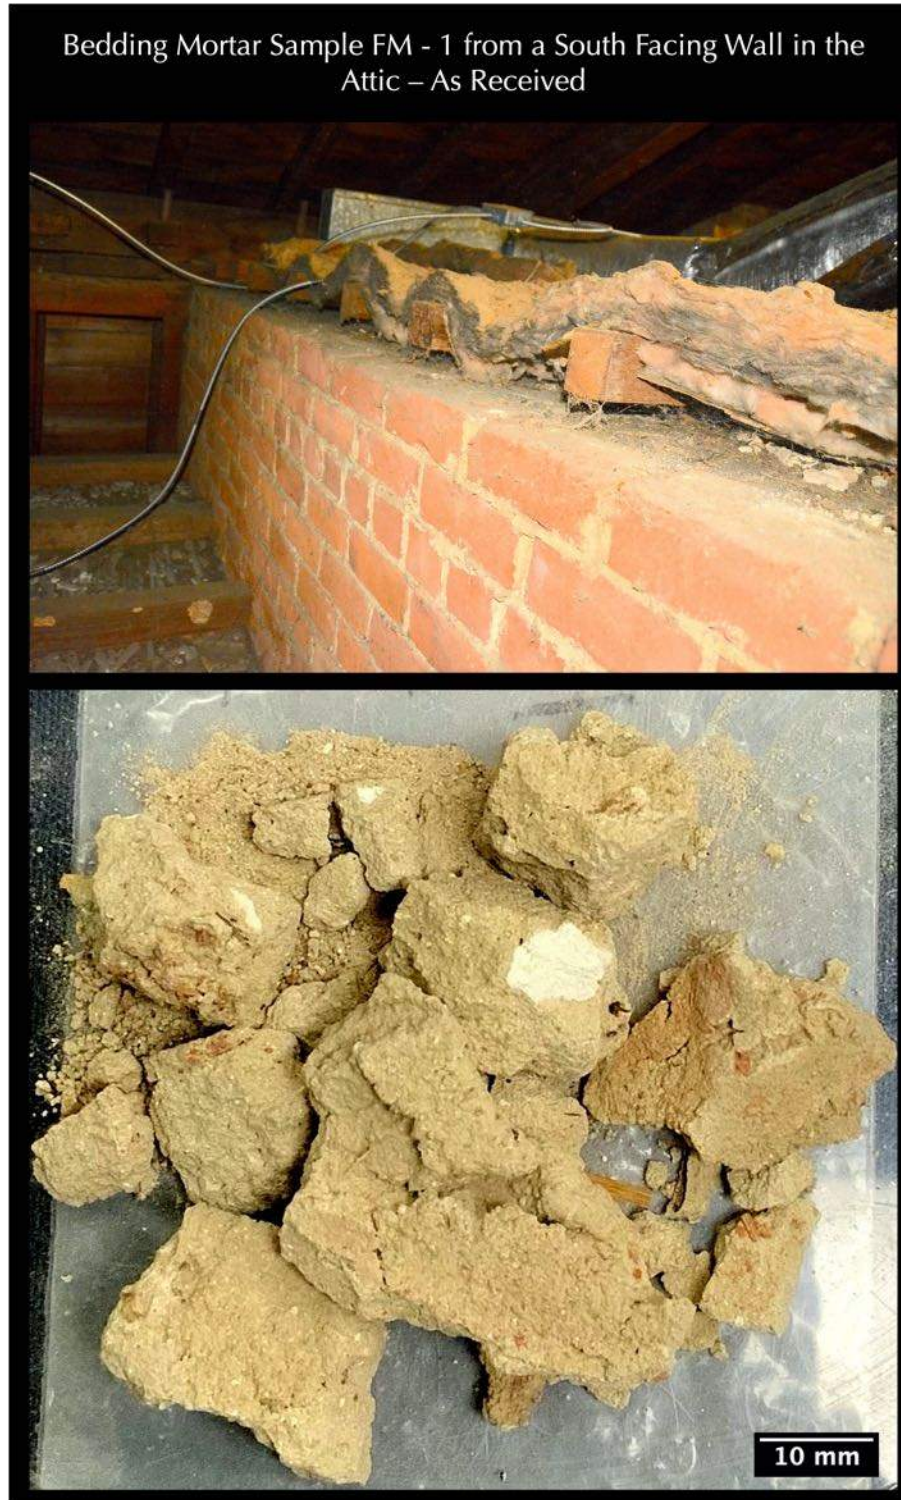
Figure 2: Location of the bed joint (top photo) from where the tan-colored fragments of mortar sample (bottom photo) was collected.

The mortar fragments are moderately hard to soft, where individual fragments are relatively intact.

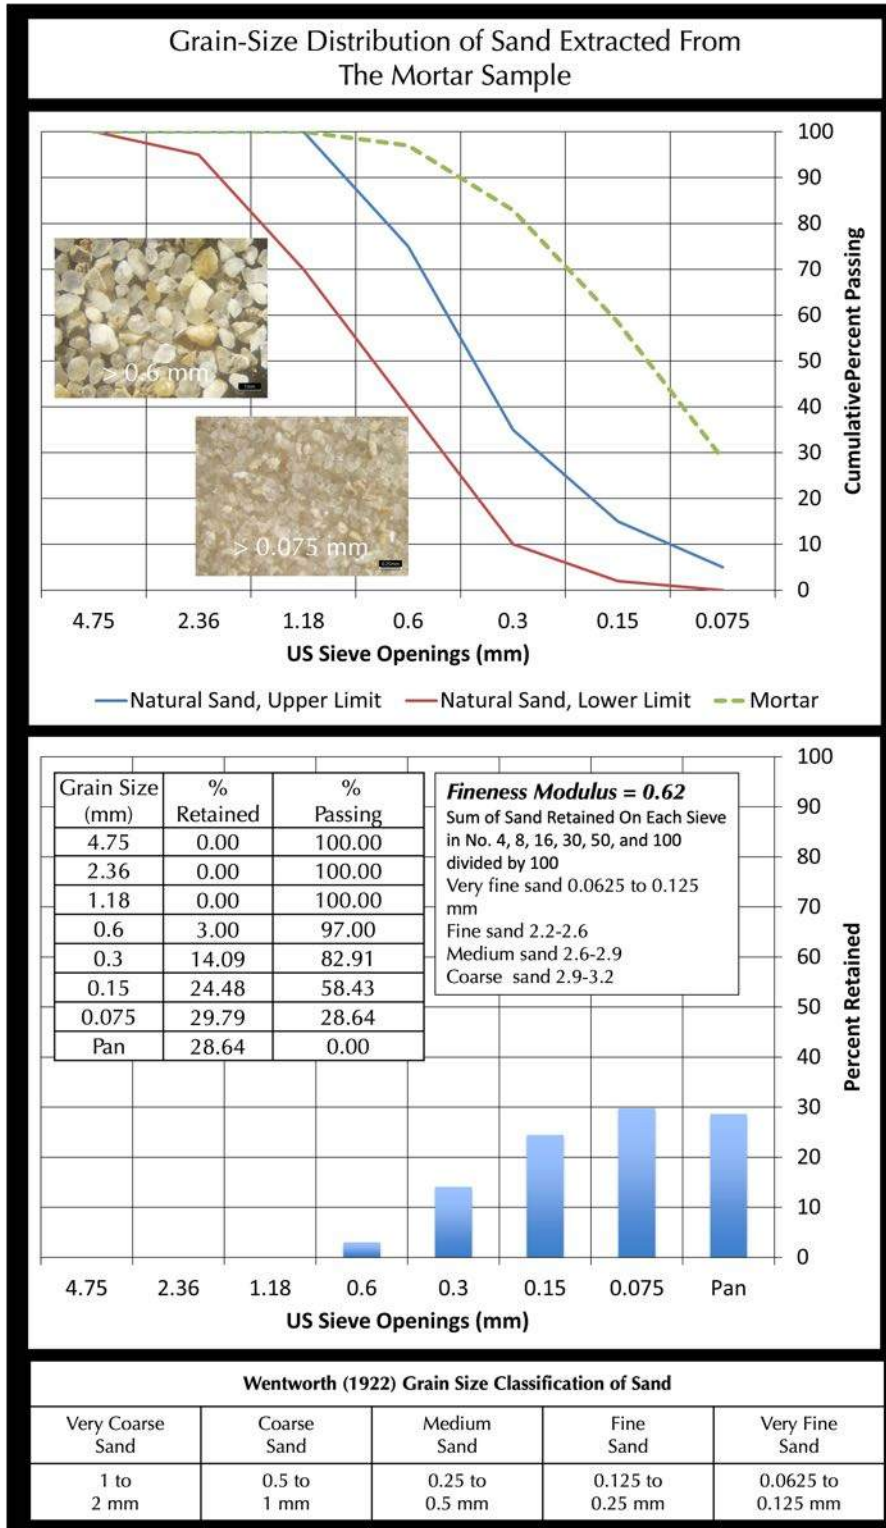
Figure 3: Grain-size distribution of sand extracted from the mortar after hydrochloric acid digestion.

In the top plot, grain size distribution of sand is compared with the upper and lower limits of natural sand in ASTM C 144 (blue and red lines, respectively) showing overall noticeably finer grain size distribution of sand compared to the size distribution of modern ASTM C 144 masonry sand.

Fineness modulus of sand is calculated to be 0.62 from the sum of cumulative percent retained on Sieves 4, 8, 16, 30, 50, and 100 divided by 100 where sand size is very fine as depicted from very low fineness modulus.

Grain-size distribution of sand extracted from the mortar after hydrochloric acid digestion showed very fine size fractions of sand (Figure 3) which are noticeably finer than the size distribution of modern masonry sand. Fineness modulus of sand determined to be only 0.62 with most of the size fractions concentrated in the less than 0.3 mm size. Figure 4 shows color, size, shape, angularity, and gradation of sand particles extracted from the mortar after acid digestion.
