HISTORIC STRUCTURE REPORT  
FLUVANNA COUNTY HISTORIC COURTHOUSE  
COUNTY OF FLUVANNA, VIRGINIA

# FLUVANNA COUNTY HISTORIC COURTHOUSE

## HISTORIC STRUCTURE REPORT

September 7, 2022

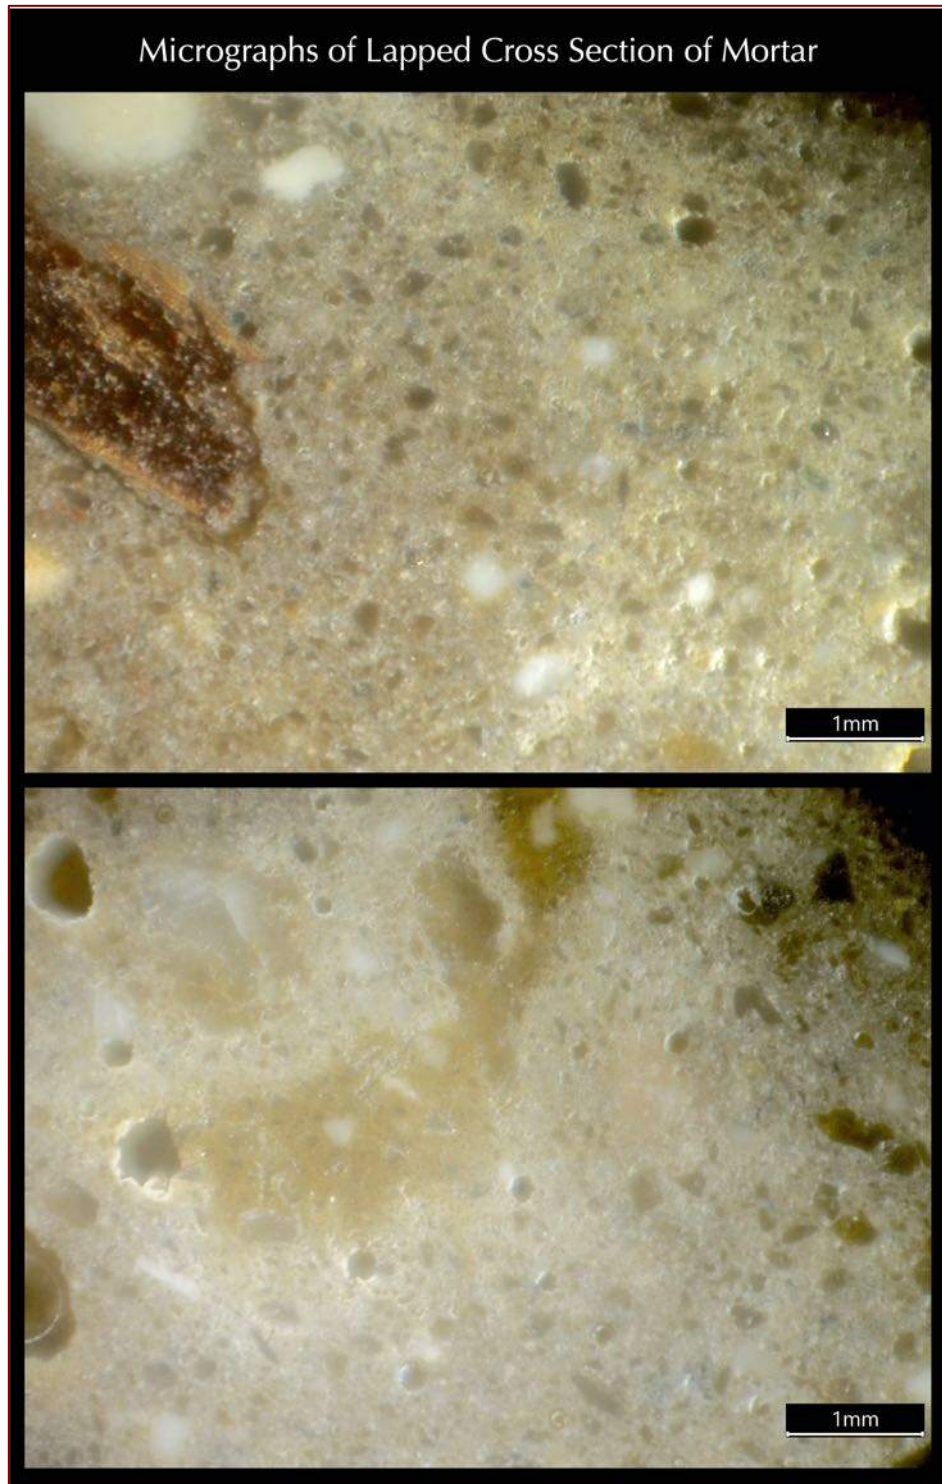
Figure 7: Micrographs of clear epoxy-impregnated cross section of mortar showing size, shape, angularity, gradation, and distribution of sand particles, where particles are variably colored, subangular to subrounded, equidimensional, well graded, and well-distributed. Notice the overall non-air-entrained nature of mortar, which is typical of historic mortars consistent with the reported early 19<sup>th</sup> century vintage.

Mortar is **non-air-entrained**, which is depicted in micrographs of lapped section in Figure 7 as well as in thin section in Figure 10, which is not unusual for its reported early 19<sup>th</sup> century derivation.

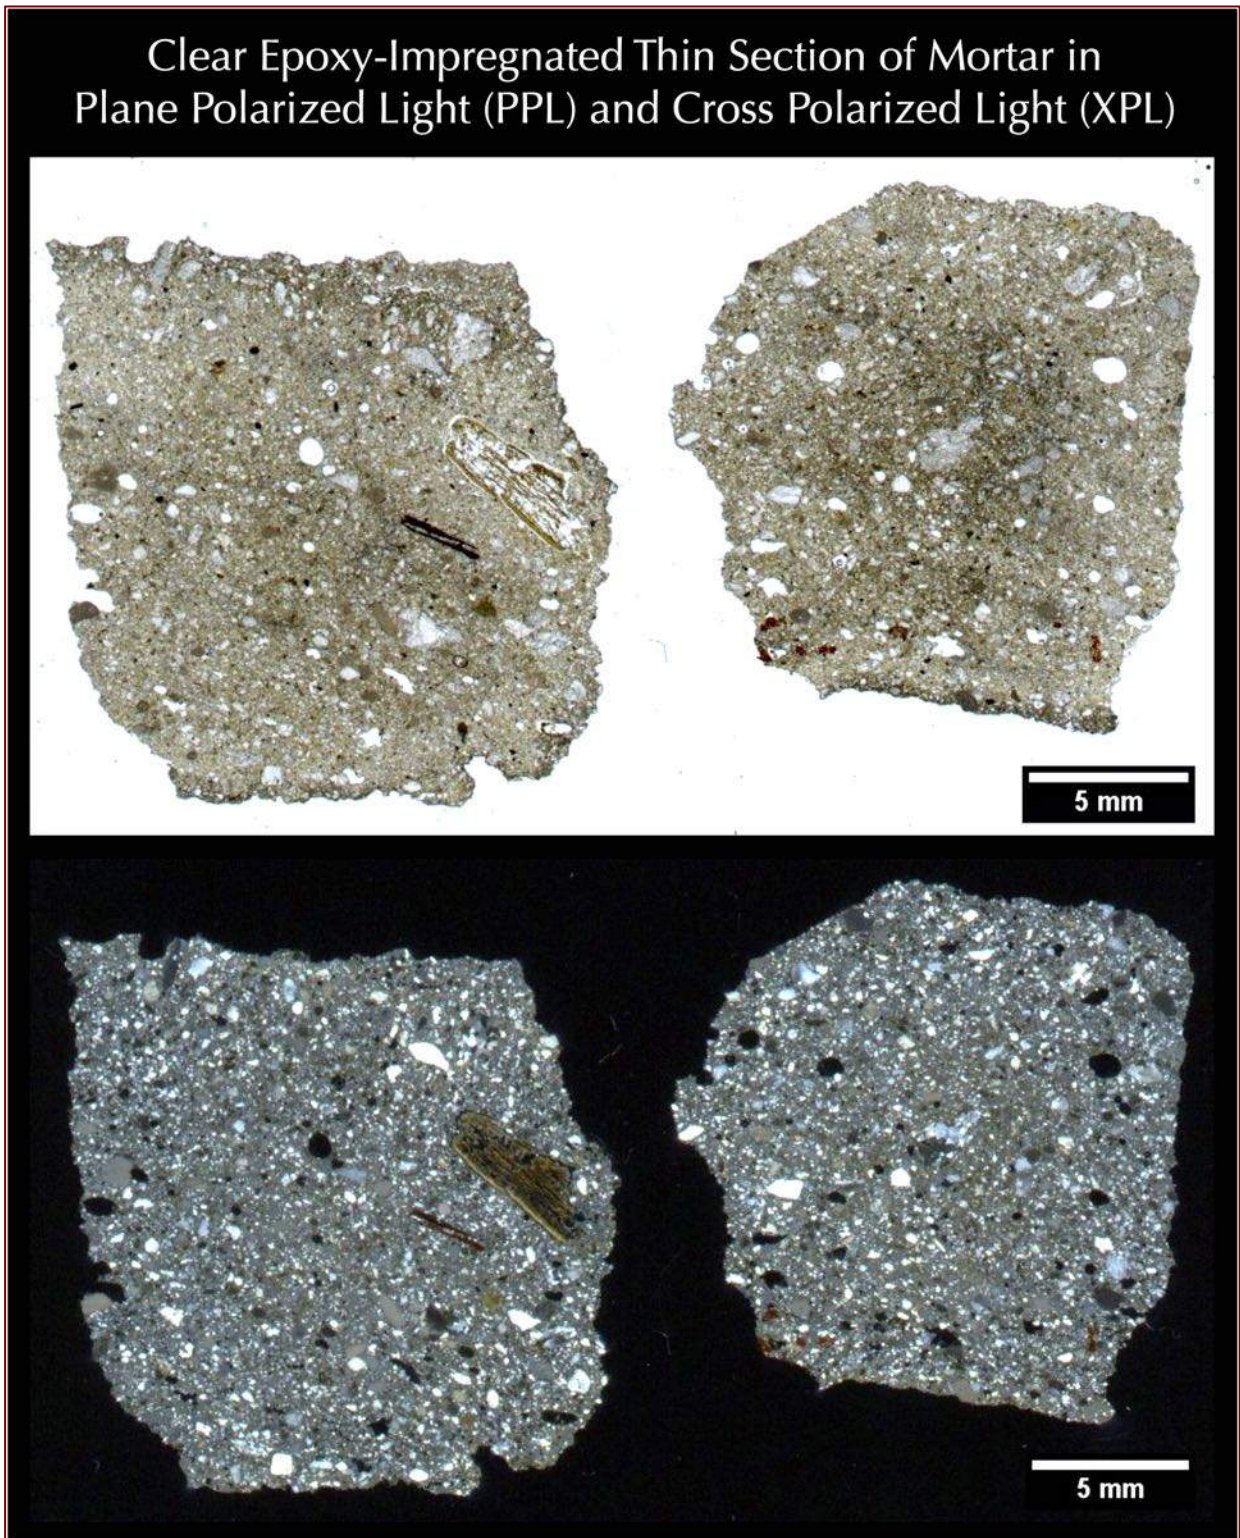
Figure 9: Clear, low viscosity epoxy-impregnated thin section of mortar taken by using a flatbed film scanner, where thin section was scanned with a polarizing filter to generate the plane polarized light (PPL) view of mortar in the top photo, and with two perpendicular polarizing filers to generate the cross polarized light (XPL) view in the bottom photo. Both photos show the very fine (< 1 mm) sand grain size, shape, angularity, and distribution. Notice a few plant fragments accidentally incorporated into the mortar during mixing and installation.

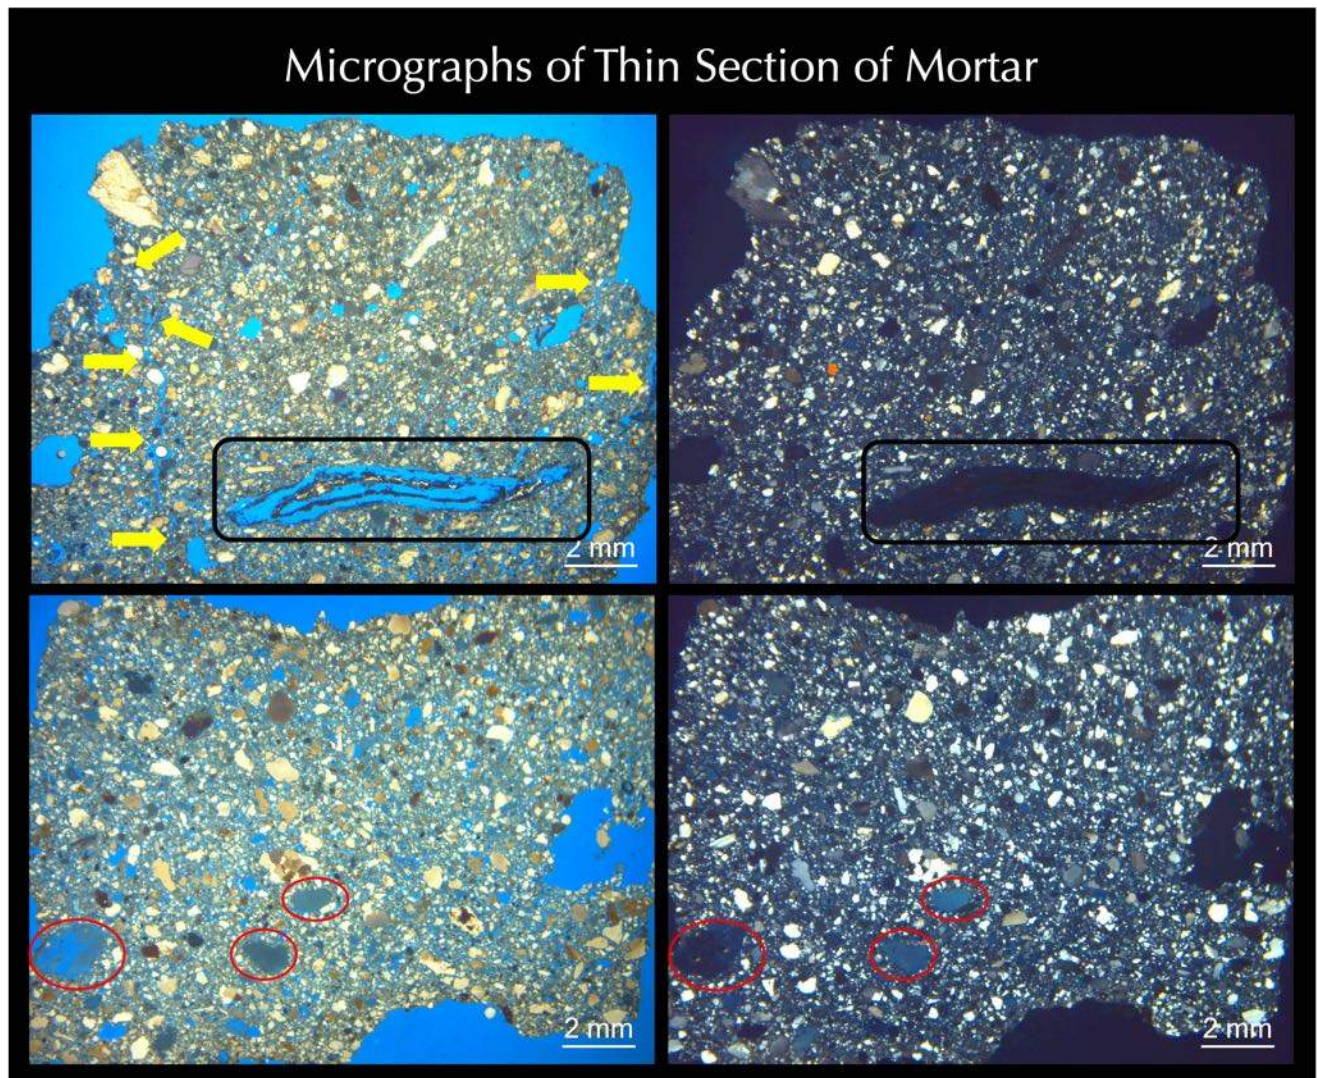
Figure 10: Micrographs of thin section of mortar taken at PPL (left column) and corresponding XPL (right column) modes in a transmitted-light stereo-zoom microscope with polarizing facility where PPL photos show the size, shape, angularity, gradation and distribution of sand particles as well as interstitial pore spaces and micrographs highlighted by the blue epoxy (yellow arrows highlight microcracks), whereas XPL photos show the overall siliceous composition of sand and dark near-isotropic nature of the interstitial paste fraction, as opposed to severely carbonated nature typical of many historic lime mortars, which indicates the presence of a component other than lime which has produced the dark near-isotropic appearance of the interstitial paste. A few unmixed lumps of lime are marked with red ellipses in the bottom row photos.

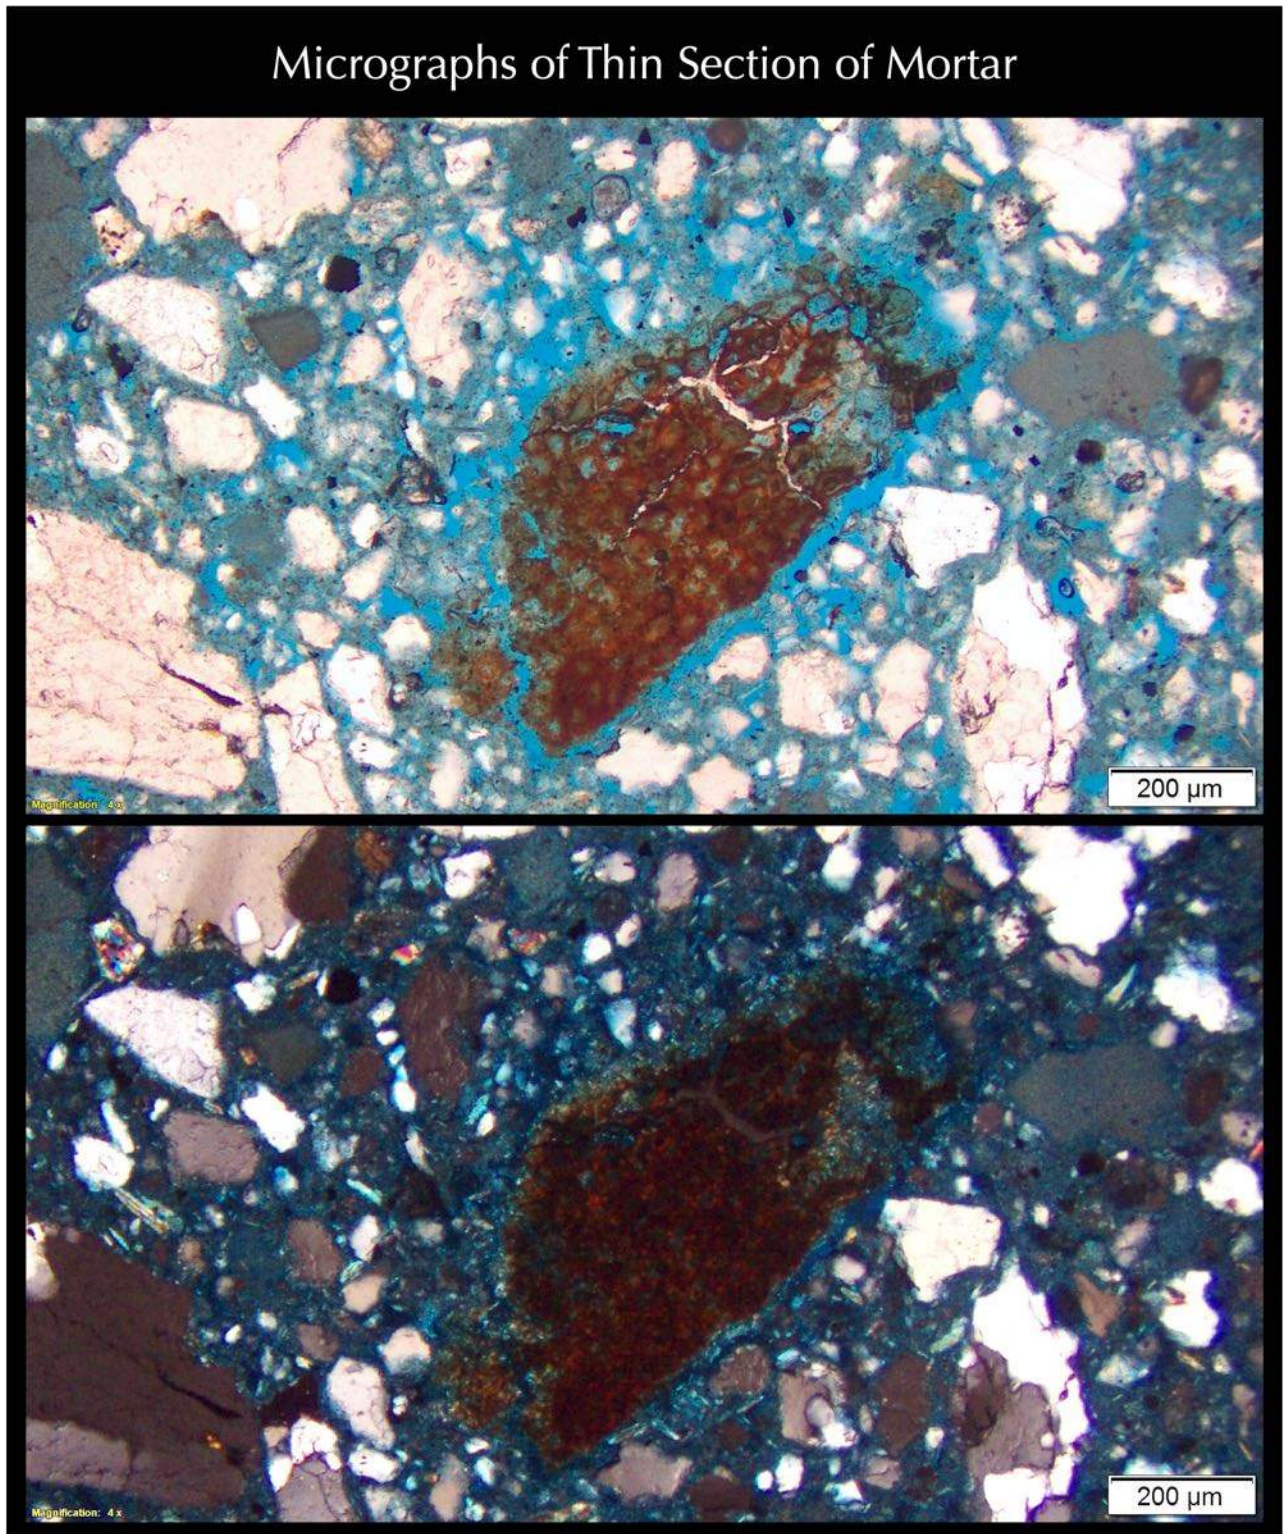
Figure 13: Micrographs of thin section of mortar showing: (a) very fine-grained, porous, carbonated to near-isotropic appearance of interstitial paste fraction; (b) subangular to subrounded, mostly equidimensional siliceous sand particles that are <1 mm in size, (c) some sheet-like flakes of mica and potential clay minerals, (d) a few lumps of unmixed lime, which also shows a near-isotropic nature in XPL photo (bottom) as opposed to severely carbonated nature commonly found in lime lumps in many historic mortars, and (e) the non-air-entrained nature of mortar. A reddish brown ferruginous silicified wood contaminant is seen at the center.

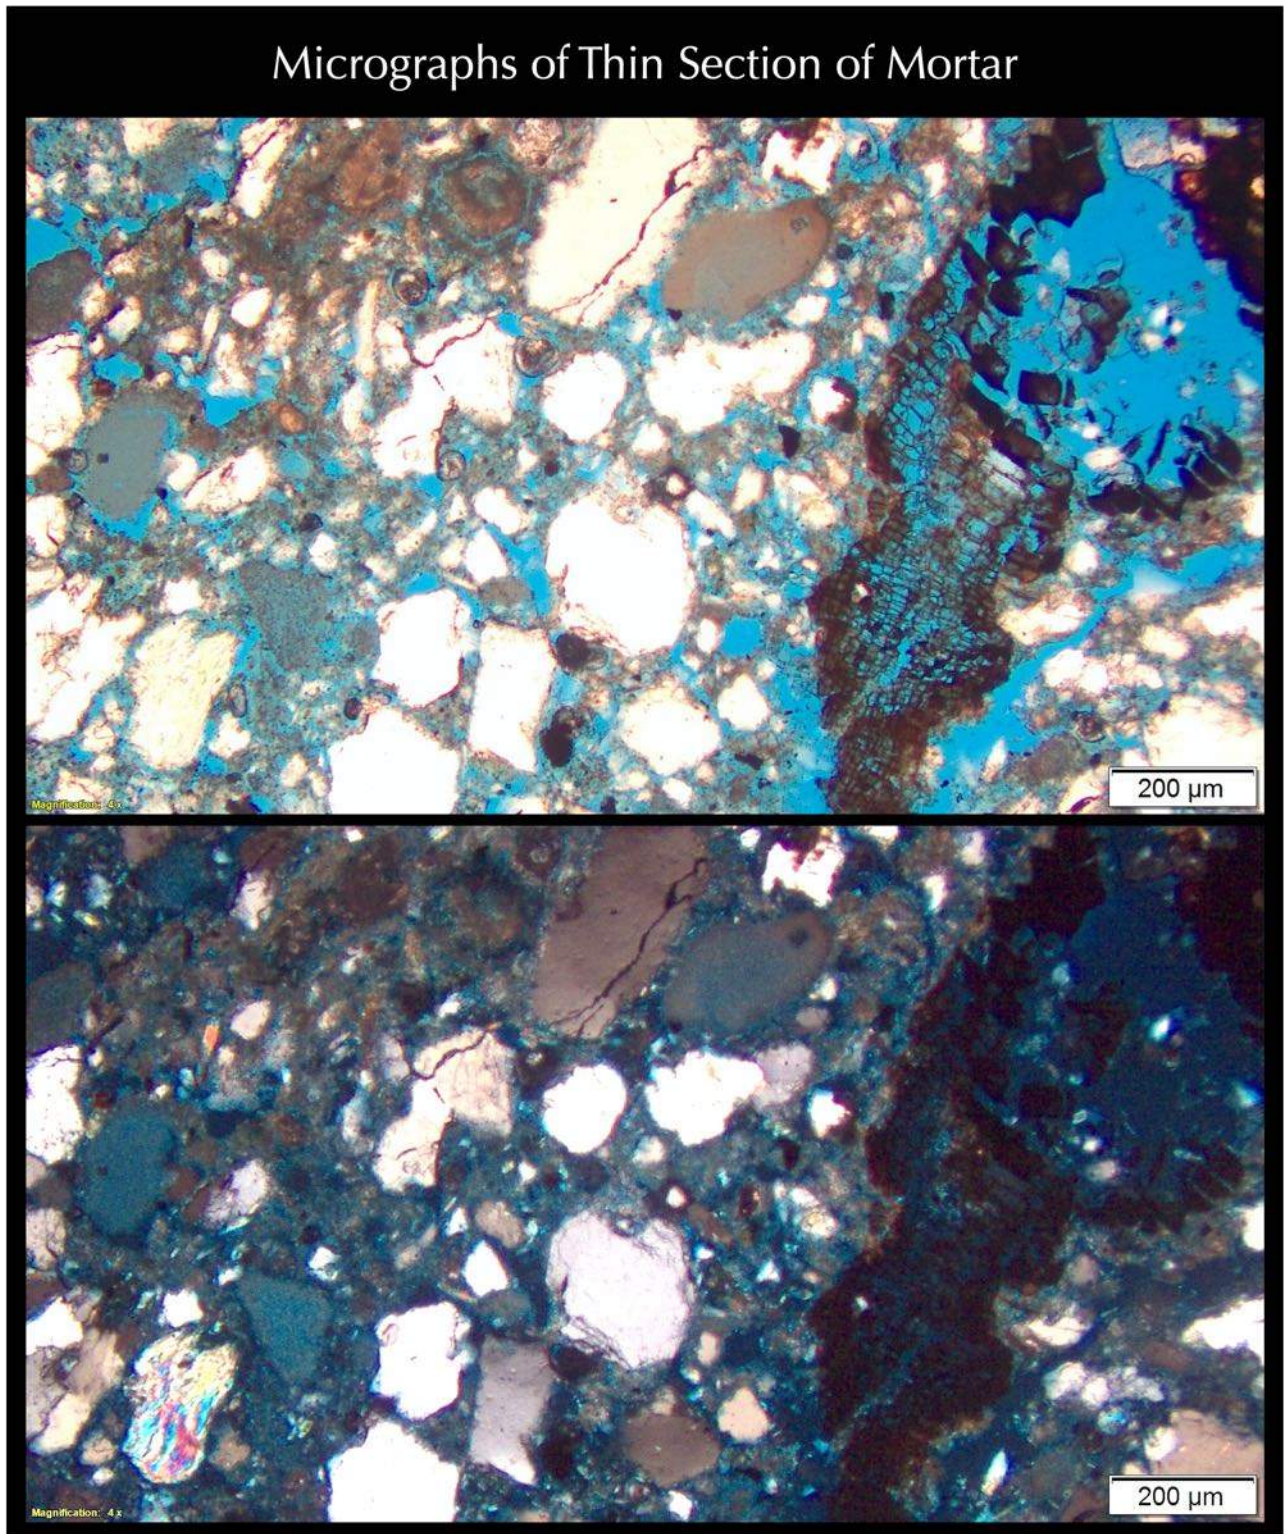
Figure 19: Micrographs of thin section of mortar showing: (a) very fine-grained, porous, carbonated to near-isotropic appearance of interstitial paste fraction; (b) subangular to subrounded, mostly equidimensional siliceous sand particles that are <1 mm in size, (c) some sheet-like flakes of mica and potential clay minerals, (d) a few lumps of unmixed lime, which also shows a near-isotropic nature in XPL photo (bottom) as opposed to severely carbonated nature commonly found in lime lumps in many historic mortars, and (e) the non-air-entrained nature of mortar. A reddish brown ferruginous silicified wood contaminant is seen at right.

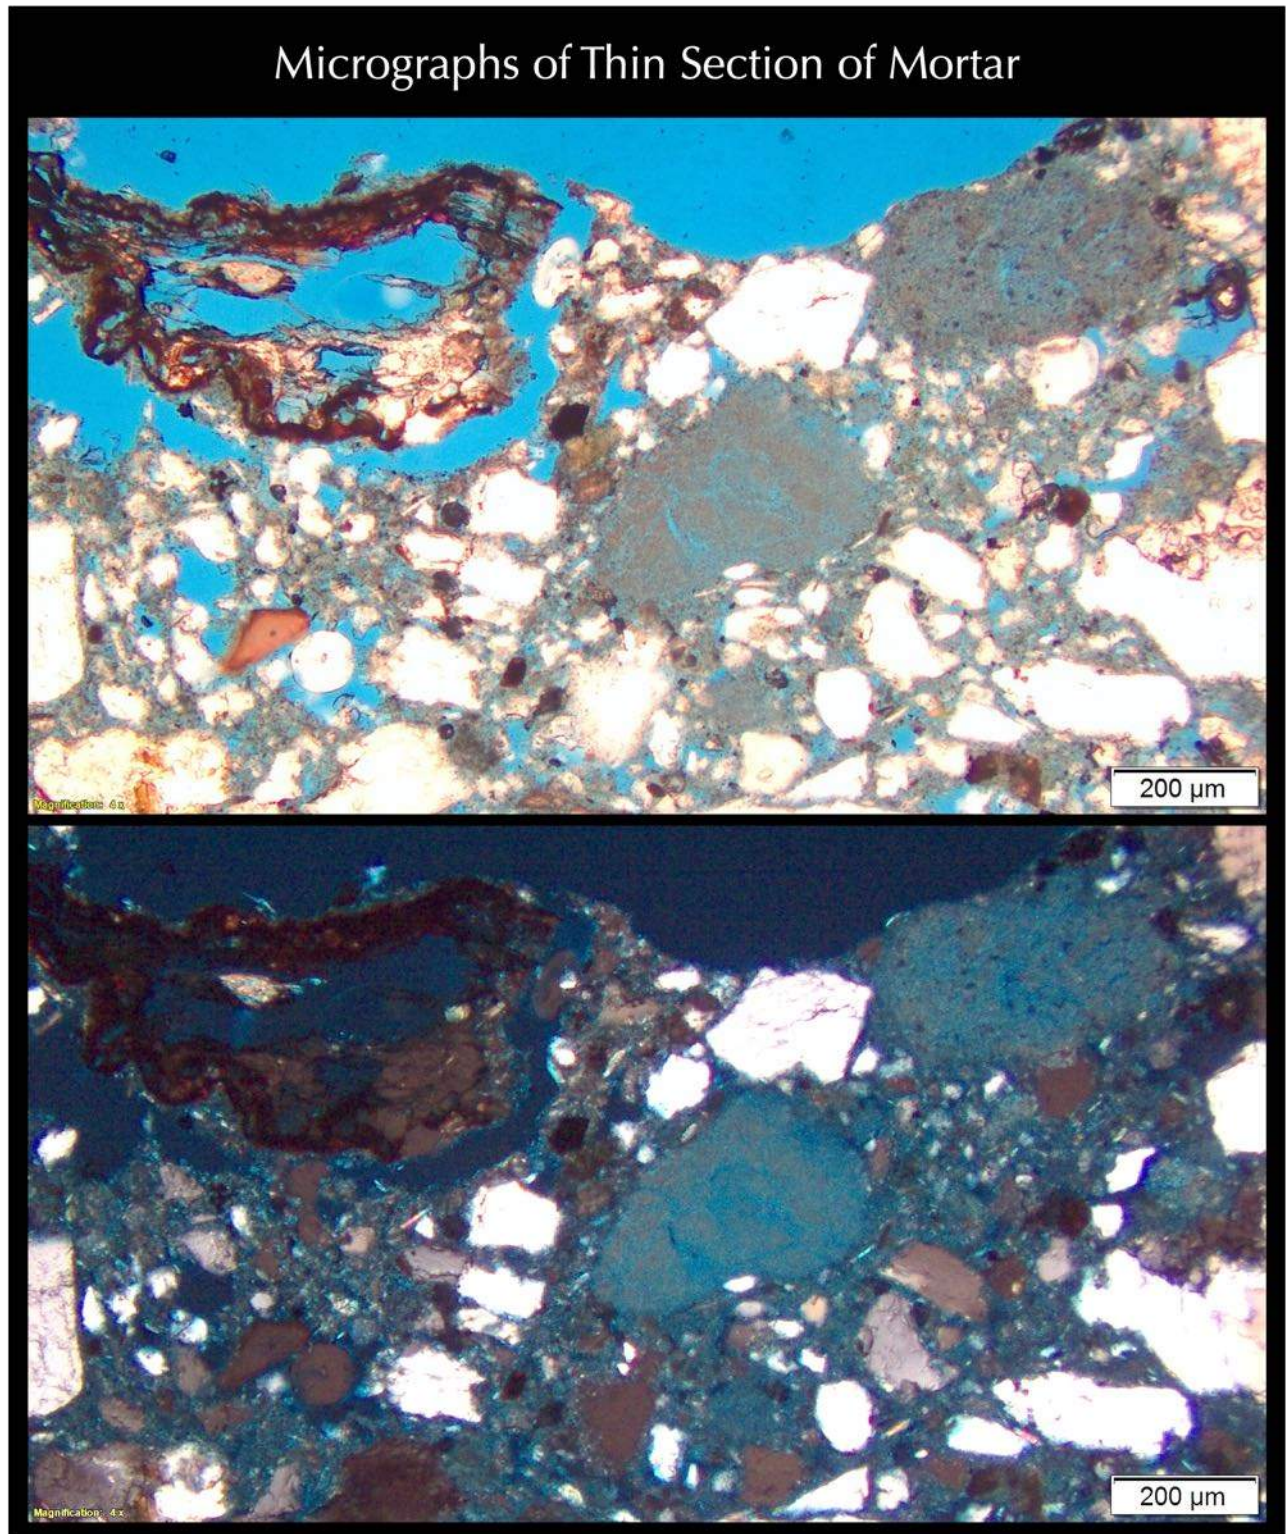
Figure 20: Micrographs of thin section of mortar showing: (a) very fine-grained, porous, carbonated to near-isotropic appearance of interstitial paste fraction; (b) subangular to subrounded, mostly equidimensional siliceous sand particles that are <1 mm in size, (c) some sheet-like flakes of mica and potential clay minerals, (d) a few lumps of unmixed lime, which also shows a near-isotropic nature in XPL photo (bottom) as opposed to severely carbonated nature commonly found in lime lumps in many historic mortars, and (e) the non-air-entrained nature of mortar. A reddish brown ferruginous silicified wood contaminant is seen at top.

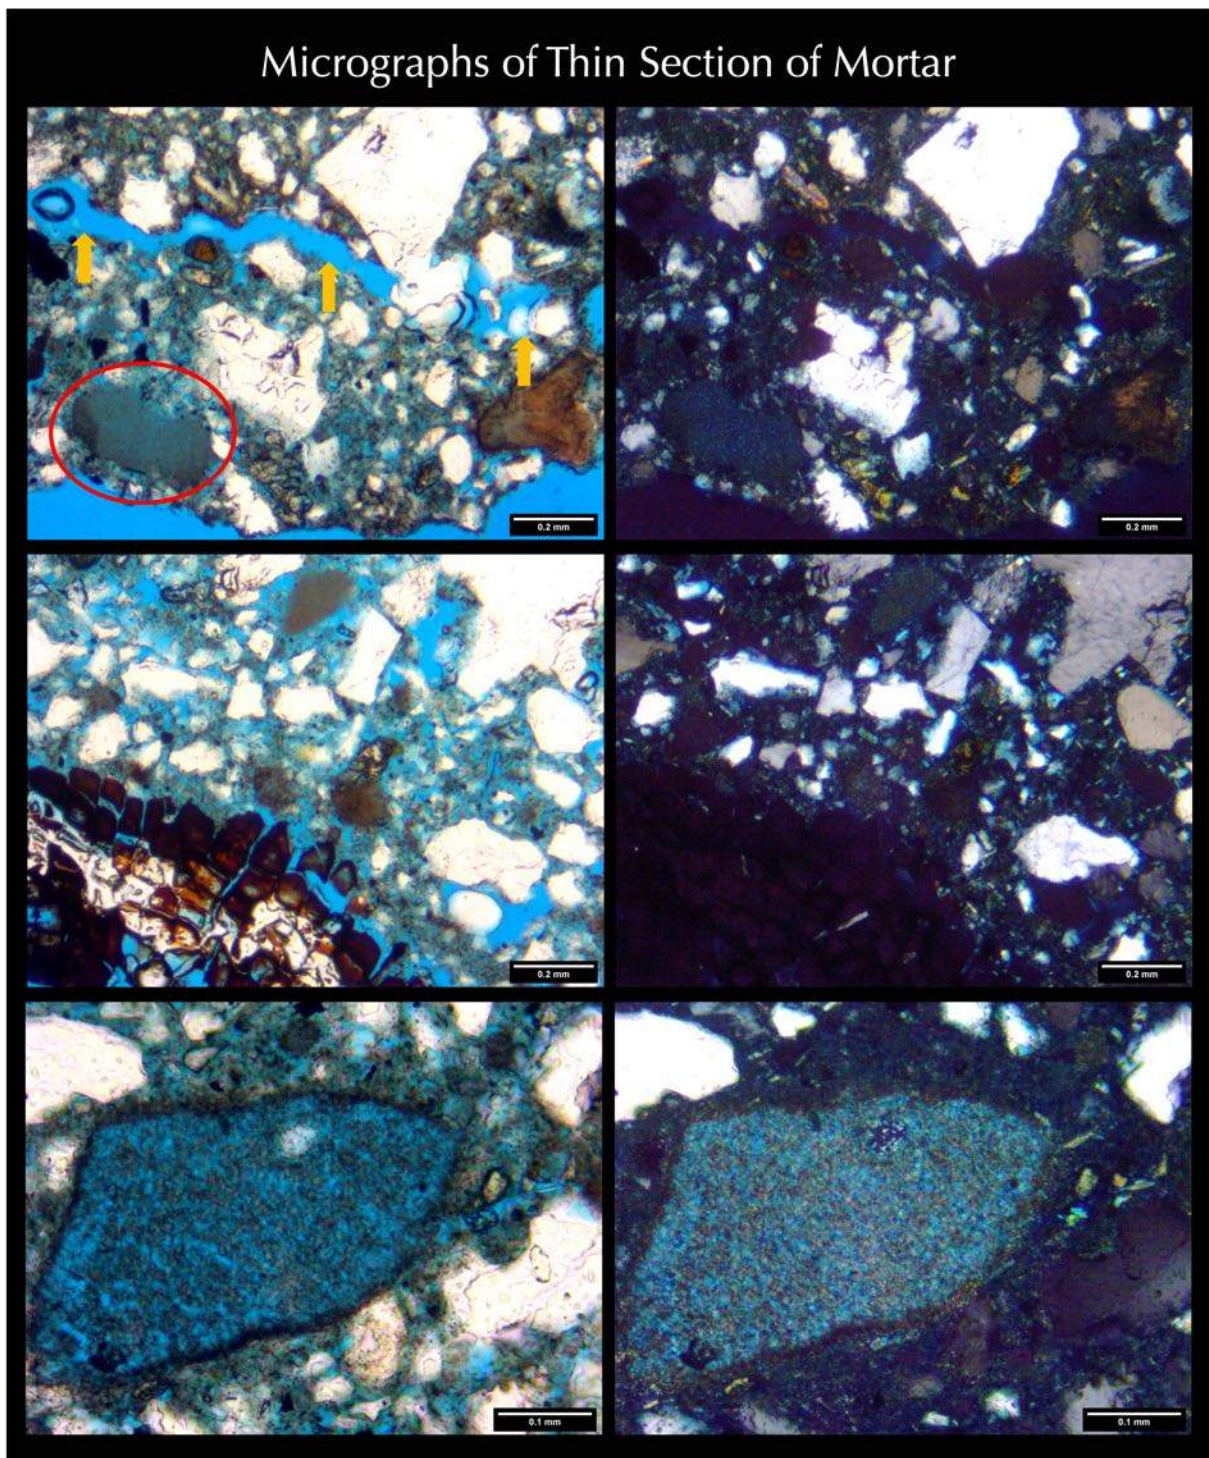
Figure 23: Micrographs of thin section of mortar showing: (a) very fine-grained, porous, mildly carbonated to near-isotropic appearance of interstitial paste fraction; (b) subangular to subrounded, mostly equidimensional siliceous sand particles that are <1 mm in size, (c) some sheet-like flakes of mica and potential clay minerals, (d) a few lumps of unmixed lime, which also shows a near-isotropic nature in XPL photo (bottom) as opposed to severely carbonated nature commonly found in lime lumps in many historic mortars, and (e) the non-air-entrained nature of mortar. A few microcracks are highlighted by blue epoxy in the top left PPL photo. A ferruginous reddish brown contaminant is seen in the middle row photos.

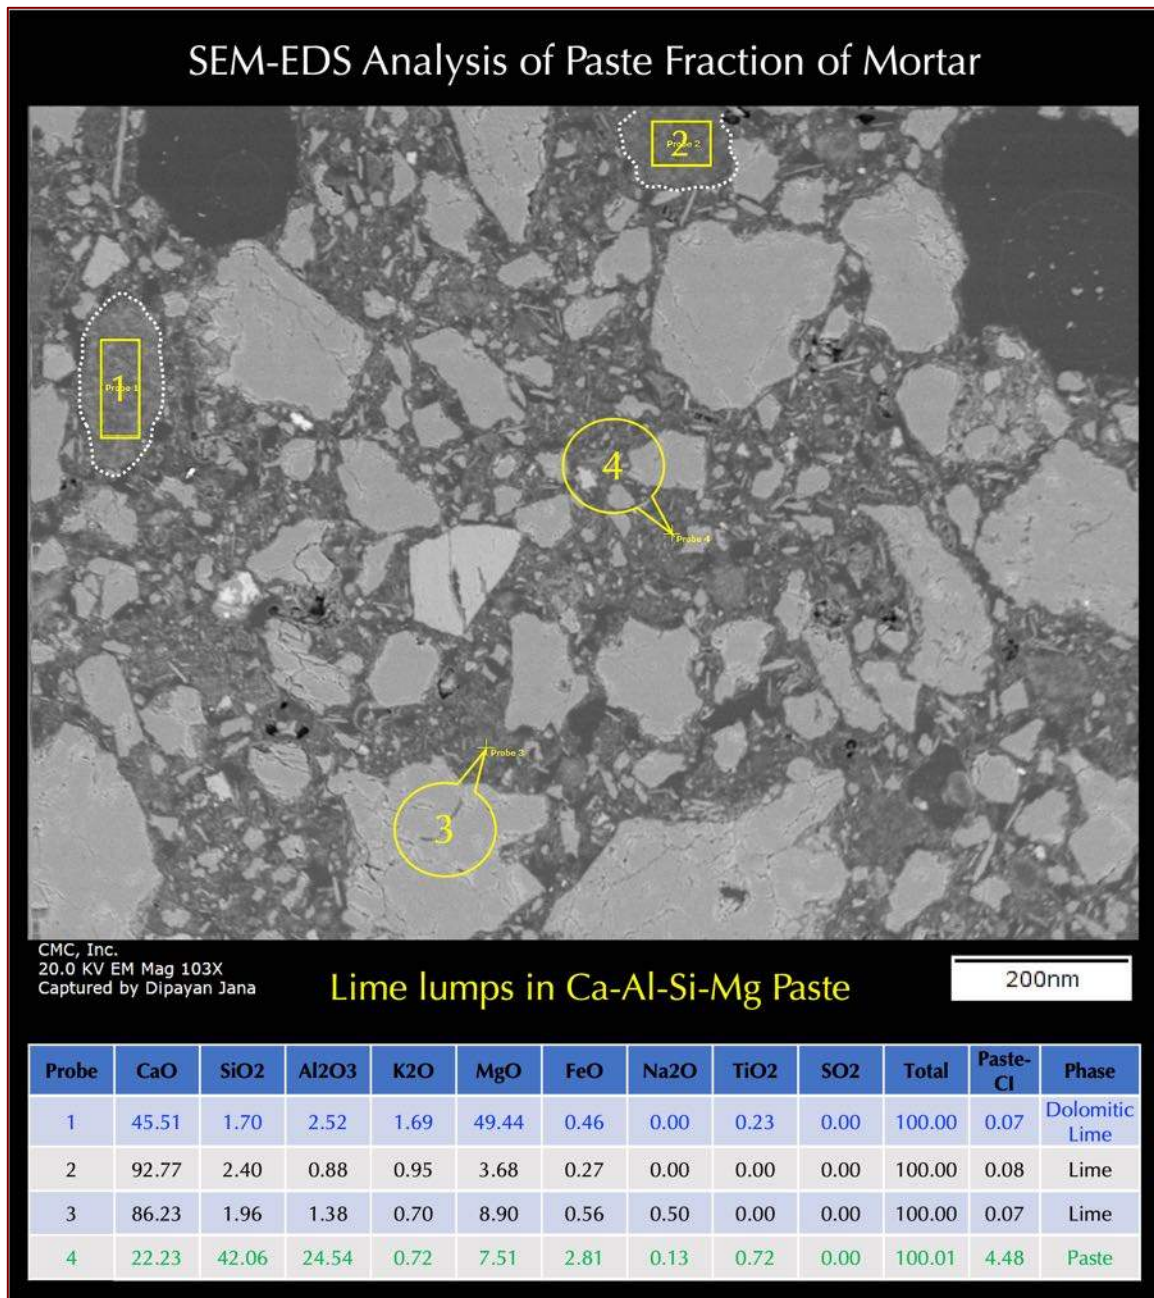
Figure 26: Backscatter electron image (top), and X-ray microanalyses at the tips of callouts and in boxed areas in Probes 1 through 4 detecting compositional variations of lime lumps and paste in the mortar. Paste and lime lump compositions are presented (bottom) as oxide variations of all detected EDS peaks normalized to 100% except carbon (from epoxy) and gold (from coating). Paste cementation indices, CI (after Eckel 1922) measure relative hydraulicity of paste e.g., non-hydraulic lime pastes have very low CI (< 0.50) compared to Portland cement pastes (CI is >1). Paste shows CI > 1 as opposed to typical <1 value for carbonated lime pastes in many historic mortars indicating the presence of silica and alumina from addition of calcined clay component as a second binder after lime. Lime lump composition shows addition of a dolomitic lime binder. The cementation indices (CI) of paste are calculated after Eckel (1922) as  $CI = [(2.8 \cdot SiO_2) + (1.1 \cdot Al_2O_3) + (0.7 \cdot Fe_2O_3)] / [(CaO) + (1.4 \cdot MgO)]$ . Lime lumps are marked by white dotted lines.

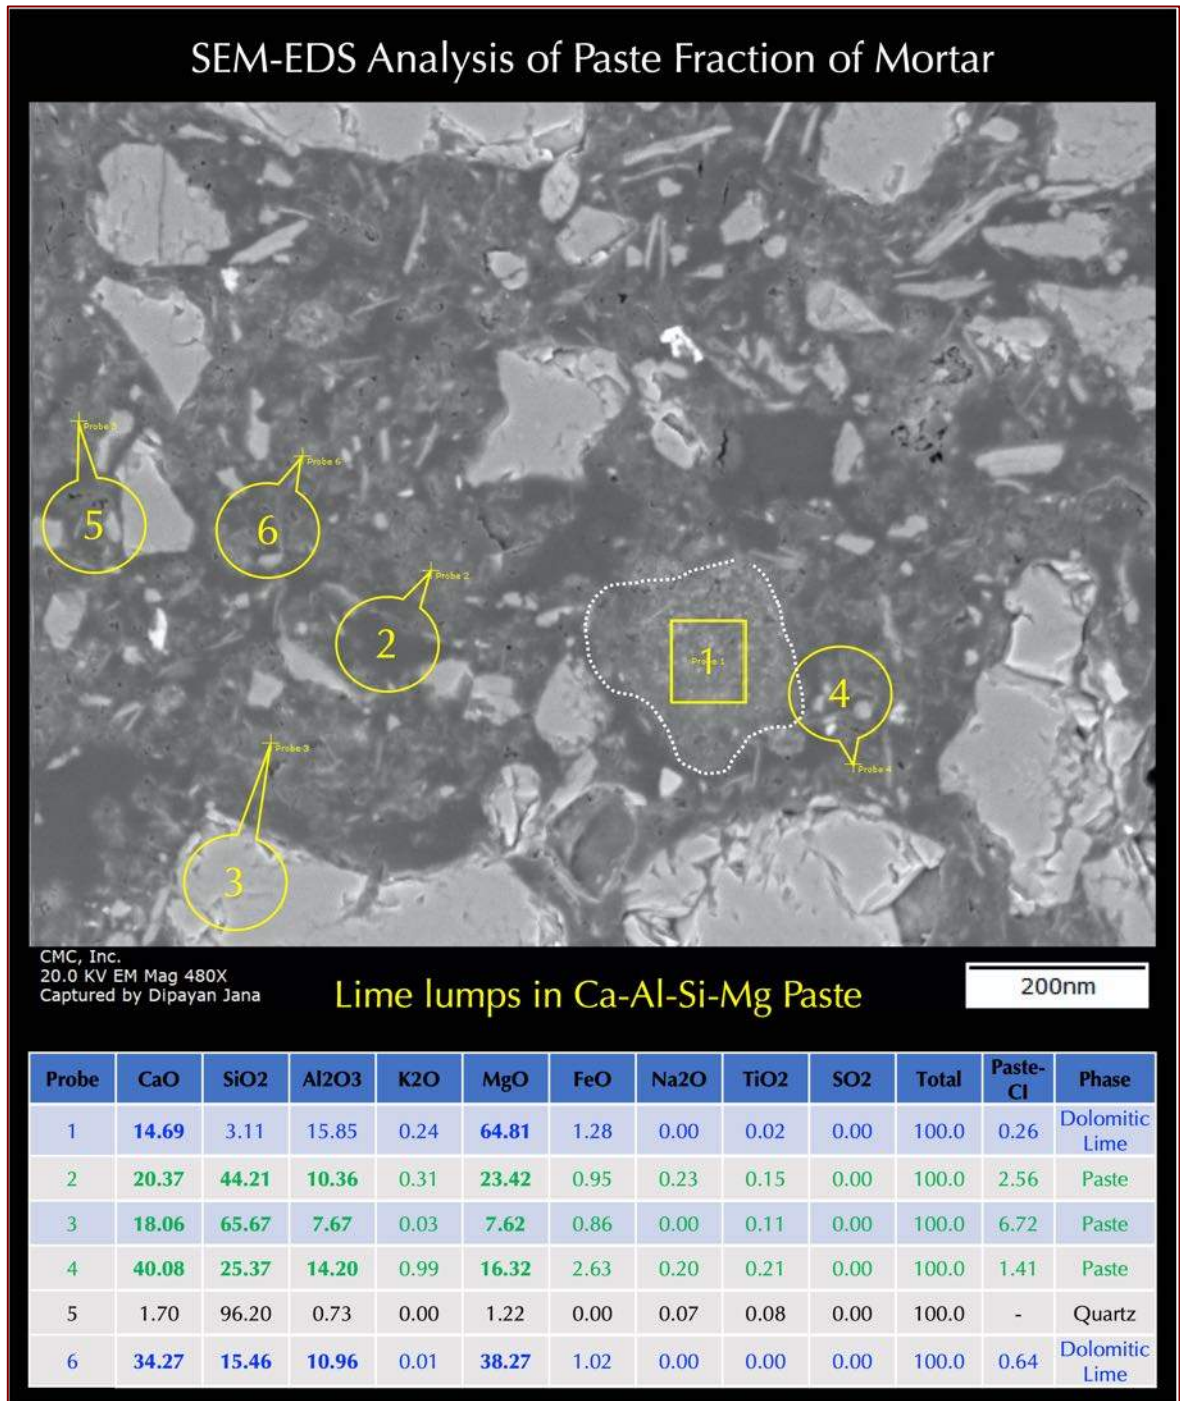
Figure 27: Backscatter electron image (top), and X-ray microanalyses at the tips of callouts and in boxed area in Probes 1 through 6 detecting compositional variations of lime lumps and paste in the mortar. Paste and lime lump compositions are presented (bottom) as oxide variations of all detected EDS peaks normalized to 100% except carbon (from epoxy) and gold (from coating). Paste cementation indices, CI (after Eckel 1922) measure relative hydraulicity of paste e.g., non-hydraulic lime pastes have very low CI (< 0.50) compared to Portland cement pastes (CI is >1). Paste shows CI > 1 as opposed to typical <1 value for carbonated lime pastes in many historic mortars indicating the presence of silica and alumina from addition of calcined clay component as a second binder after lime. Lime lump composition shows addition of a dolomitic lime binder. The cementation indices (CI) of paste are calculated after Eckel (1922) as  $CI = [(2.8 * SiO_2) + (1.1 * Al_2O_3) + (0.7 * Fe_2O_3)] / [(CaO) + (1.4 * MgO)]$ . Lime lumps are marked by white dotted lines.

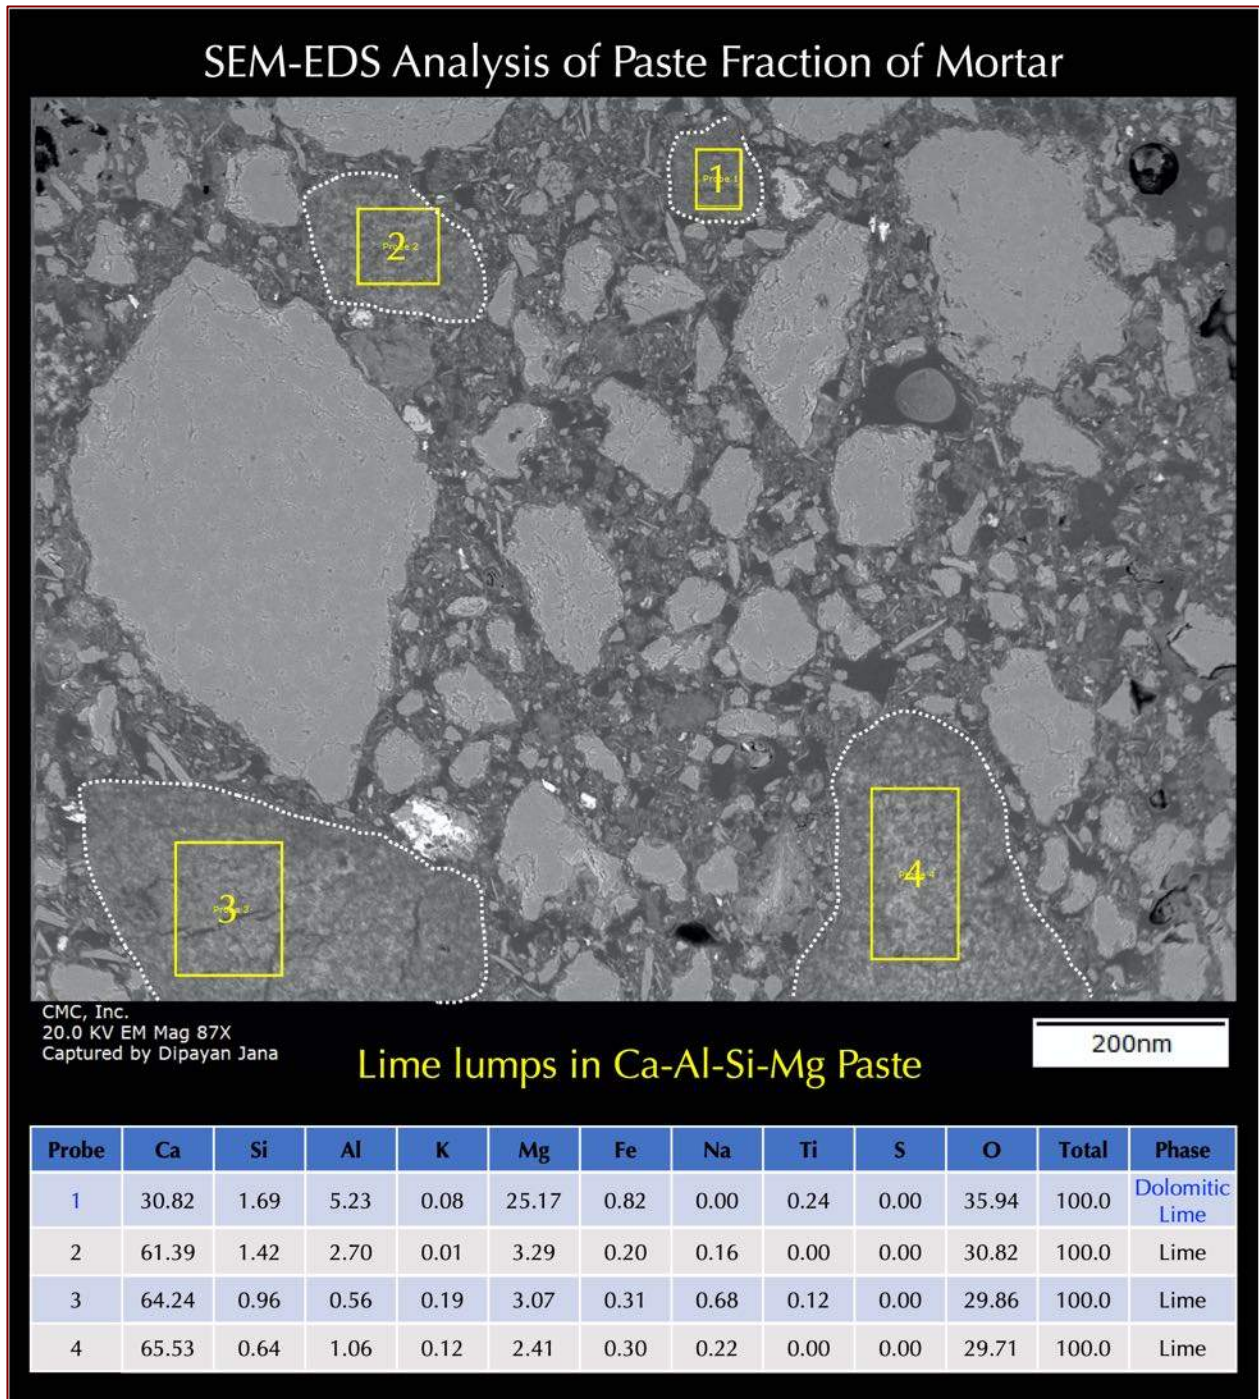
Figure 28: Backscatter electron image (top), and X-ray microanalyses at the tips of callouts and in boxed areas in Probes 1 through 4 detecting compositional variations of lime lumps in the mortar. Lime lump compositions are presented (bottom) as oxide variations of all detected EDS peaks normalized to 100% except carbon (from epoxy) and gold (from coating). Paste cementation indices, CI (after Eckel 1922) measure relative hydraulicity of paste e.g., non-hydraulic lime pastes have very low CI (< 0.50) compared to Portland cement pastes (CI is >1). Lime shows CI < 1 which are consistent with carbonated lime pastes in many historic mortars. Lime lump compositions show addition of a dolomitic lime binder from where leaching of magnesia component has occurred during service to cause between-lump variations in Ca/Mg ratios. Lime lumps are marked by white dotted lines.

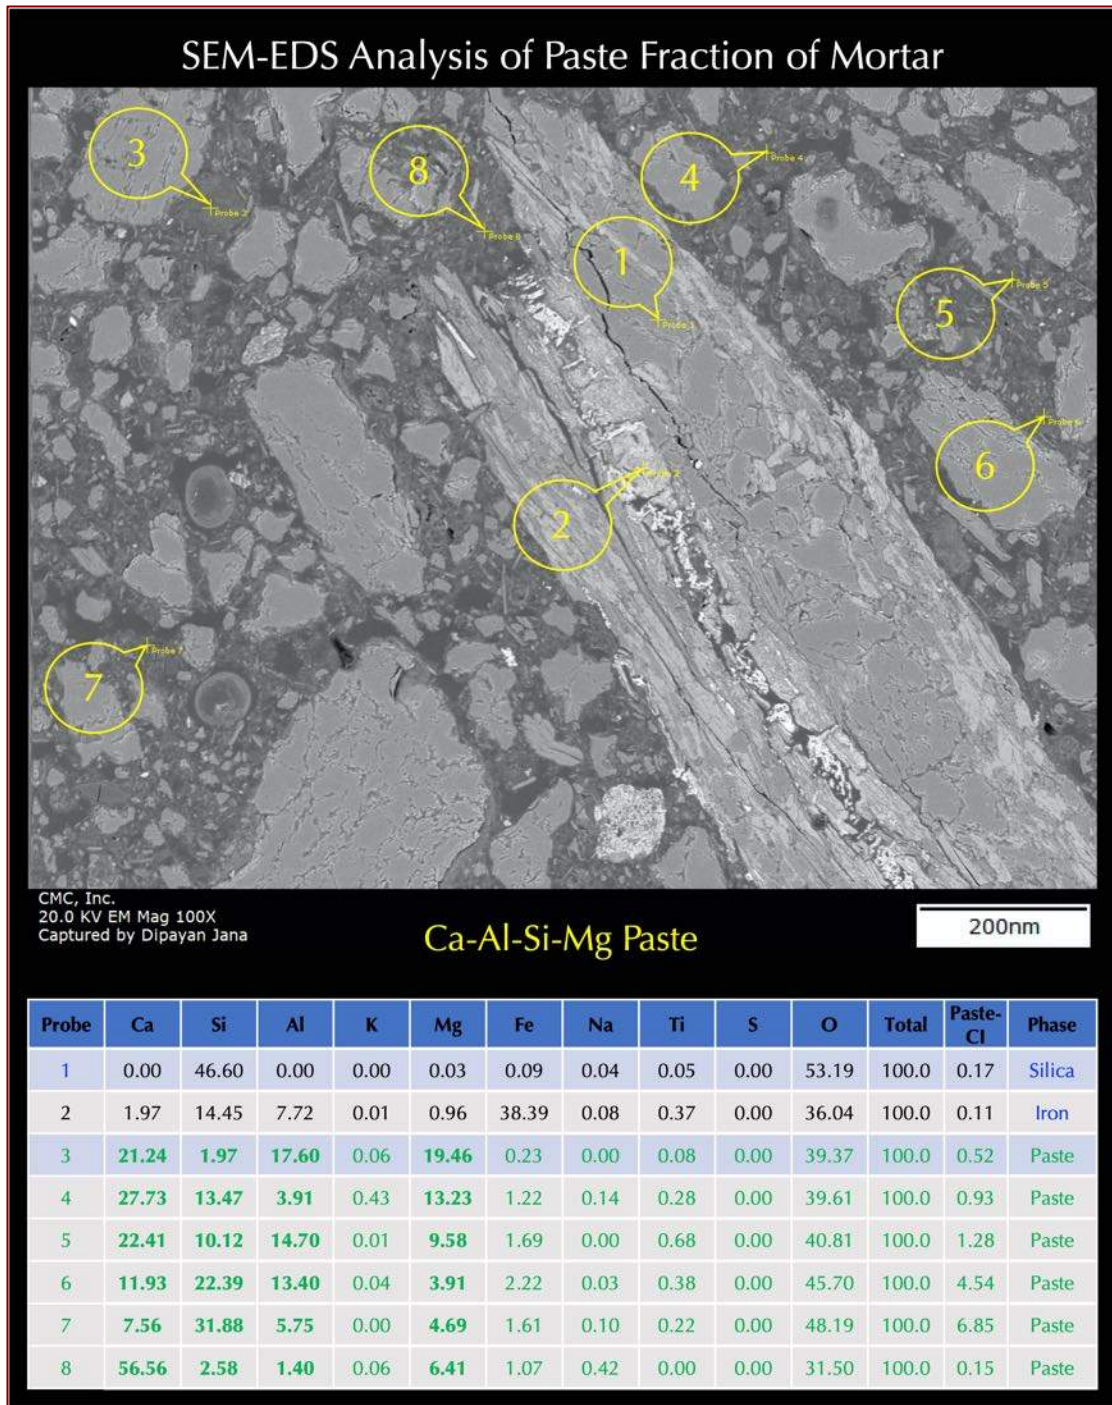
Figure 29: Backscatter electron image (top), and X-ray microanalyses at the tips of callouts in Probes 1 through 8 detecting compositional variations of paste and a contaminant in the mortar. Paste and contaminant compositions are presented (bottom) as oxide variations of all detected EDS peaks normalized to 100% except carbon (from epoxy) and gold (from coating). Paste cementation indices, CI (after Eckel 1922) measure relative hydraulicity of paste e.g., non-hydraulic lime pastes have very low CI (< 0.50) compared to Portland cement pastes (CI is >1). Paste shows mostly CI > 1 as opposed to typical <1 value for carbonated lime pastes in many historic mortars indicating the presence of silica and alumina from addition of calcined clay component as a second binder after lime. The cementation indices (CI) of paste are calculated after Eckel (1922) as  $CI = [(2.8 \cdot SiO_2) + (1.1 \cdot Al_2O_3) + (0.7 \cdot Fe_2O_3)] / [(CaO) + (1.4 \cdot MgO)]$ . The contaminant at the center shows silica and iron from ferruginous silicified composition as seen in optical micrographs.
