HISTORIC STRUCTURE REPORT  
FLUVANNA COUNTY HISTORIC COURTHOUSE  
COUNTY OF FLUVANNA, VIRGINIA

# FLUVANNA COUNTY HISTORIC COURTHOUSE

## HISTORIC STRUCTURE REPORT

September 7, 2022

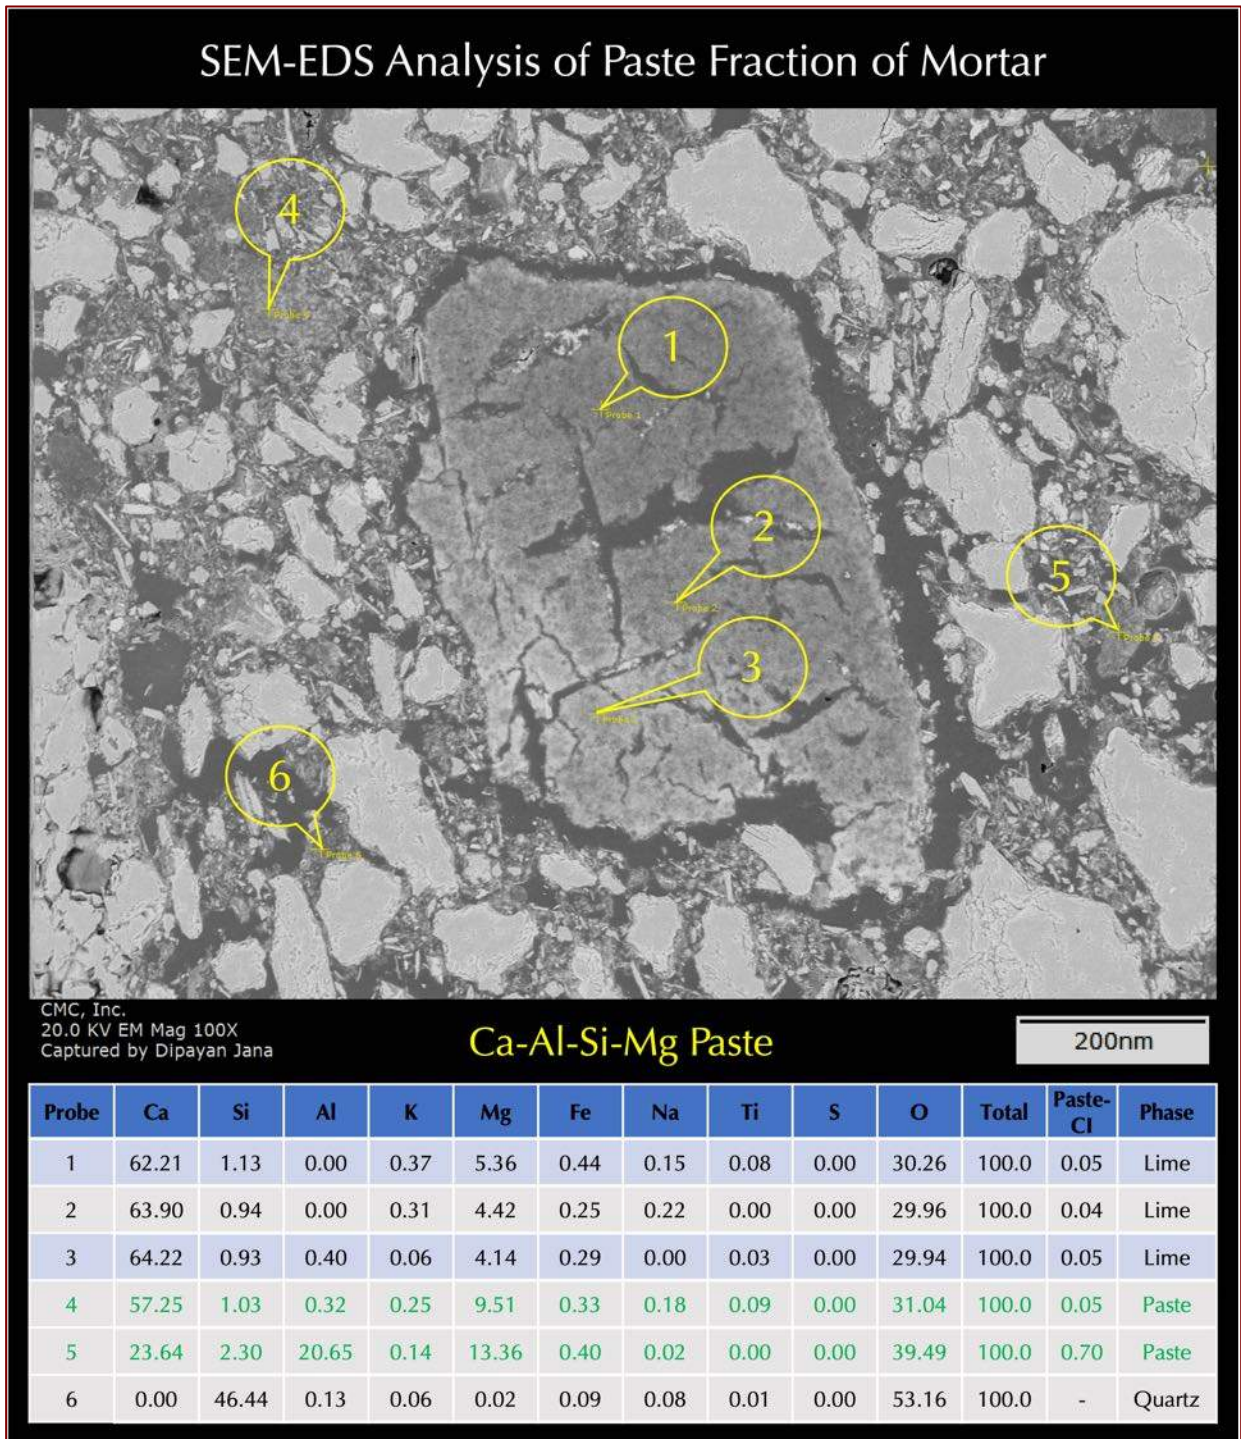
Figure 30: Backscatter electron image (top), and X-ray microanalyses at the tips of callouts in Probes 1 through 6 detecting compositional variations of a central incompletely burnt dolomitic lime and neighboring paste in the mortar. Compositions are presented (bottom) as oxide variations of all detected EDS peaks normalized to 100% except carbon (from epoxy) and gold (from coating). Paste cementation indices, CI (after Eckel 1922) measure relative hydraulicity of paste e.g., non-hydraulic lime pastes have very low CI (< 0.50) compared to Portland cement pastes (CI is >1). Both the central lime and neighboring paste show CI < 1. The cementation indices (CI) of paste are calculated after Eckel (1922) as  $CI = [(2.8 \cdot SiO_2) + (1.1 \cdot Al_2O_3) + (0.7 \cdot Fe_2O_3)] / [(CaO) + (1.4 \cdot MgO)]$ . Probe #6 is from a fine quartz sand particle.

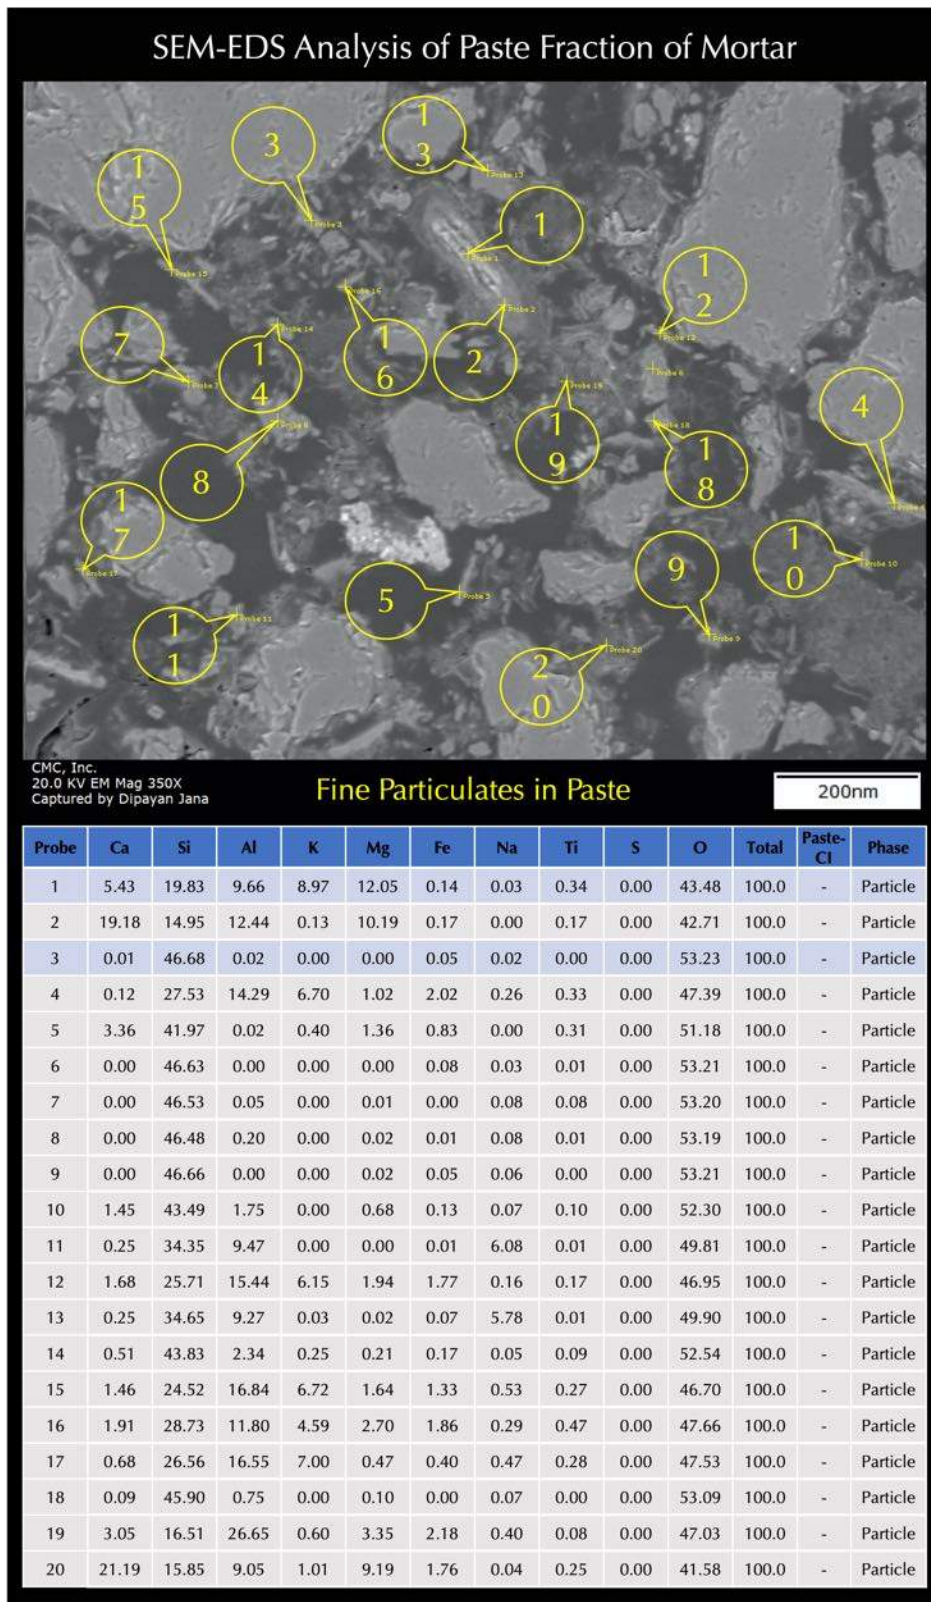
Figure 31: Backscatter electron image (top), and X-ray microanalyses at the tips of callouts and in boxed areas in Probes 1 through 20 detecting compositional variations of various fine particulates scattered throughout the interstitial fractions between siliceous sand.

Compositional variations show the presence of mica and clay particles along with major amount of siliceous sand.

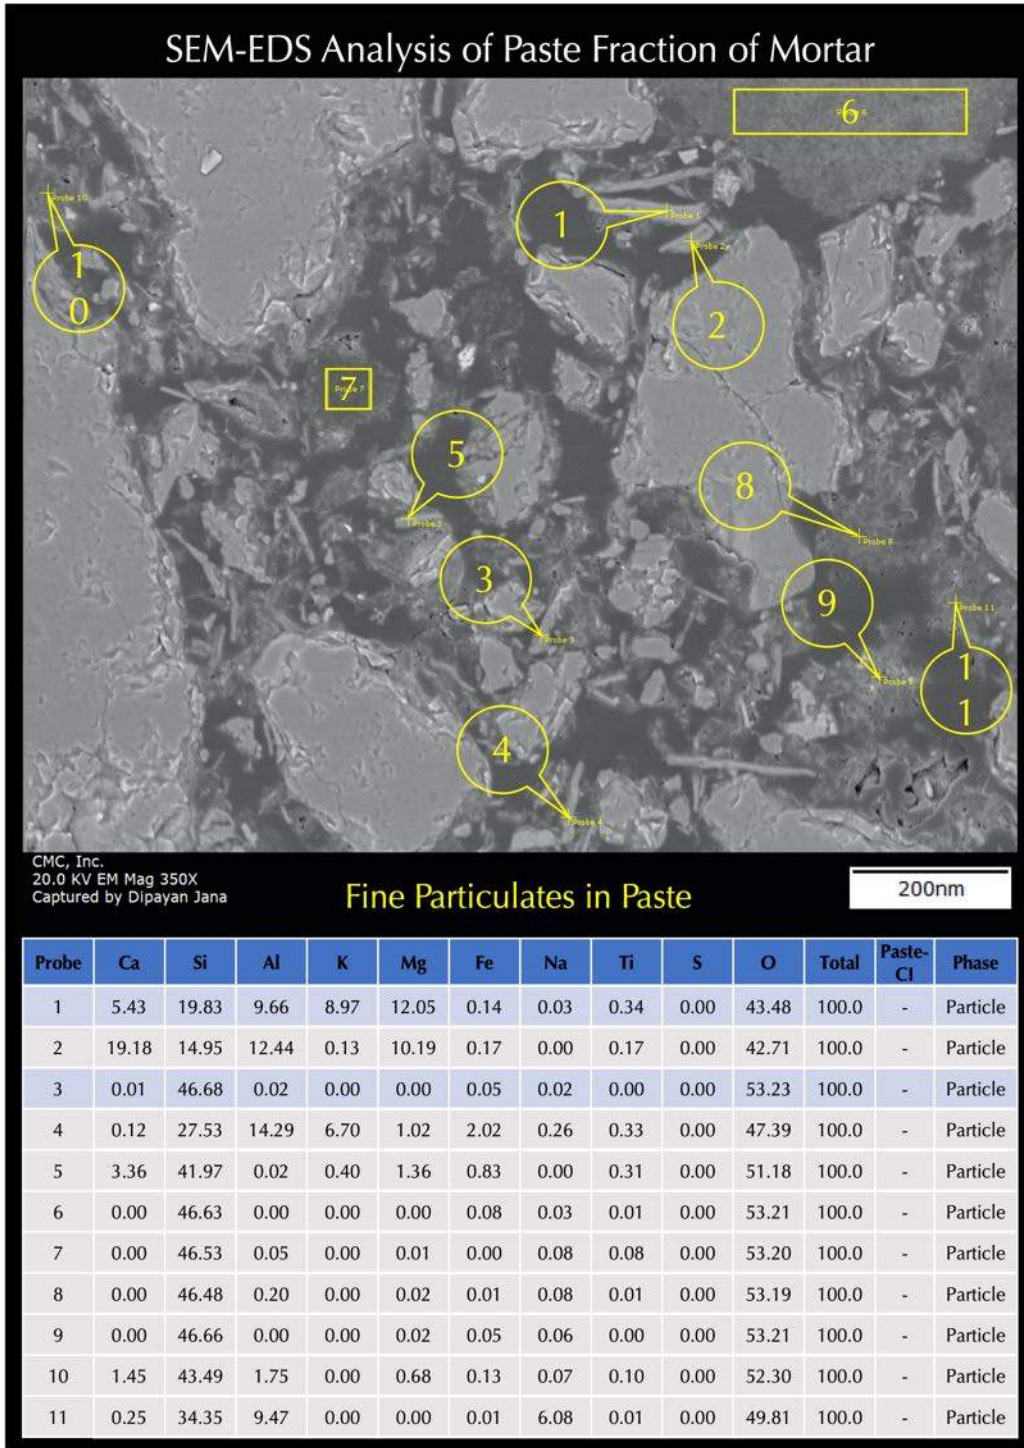
Figure 32: Backscatter electron image (top), and X-ray microanalyses at the tips of callouts and in boxed areas in Probes 1 through 20 detecting compositional variations of various fine particulates scattered throughout the interstitial fractions between siliceous sand.

Compositional variations show the presence of mica and clay particles along with major amount of siliceous sand.

Probe #6 is from a lime lump which shows calcitic lime composition.

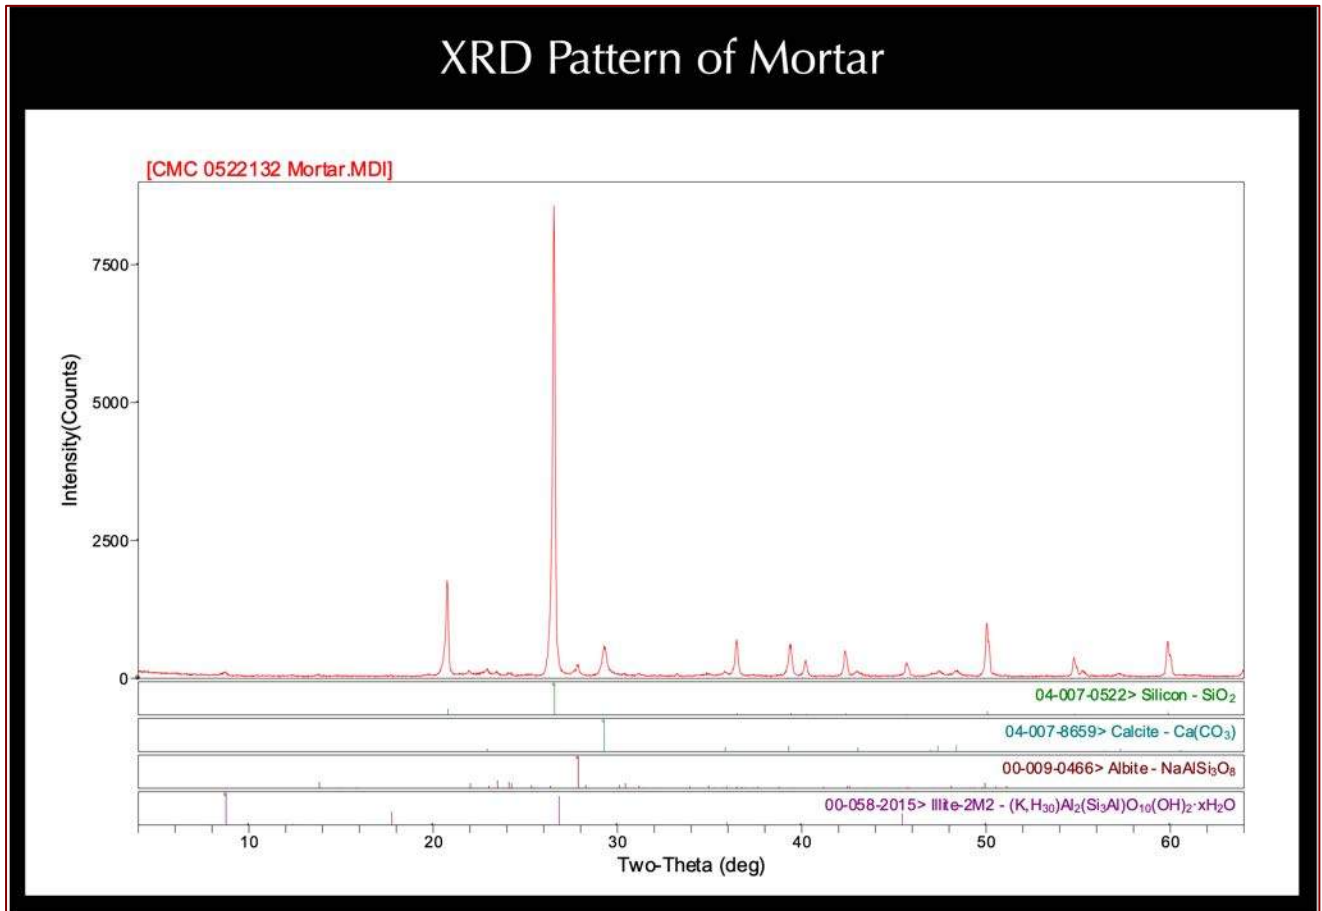
Figure 33: X-ray diffraction pattern of bulk mortar sample showing the dominance of quartz from silica sand, subordinate calcite from the lime binder and trace albite and illitic clay from the sand particles.

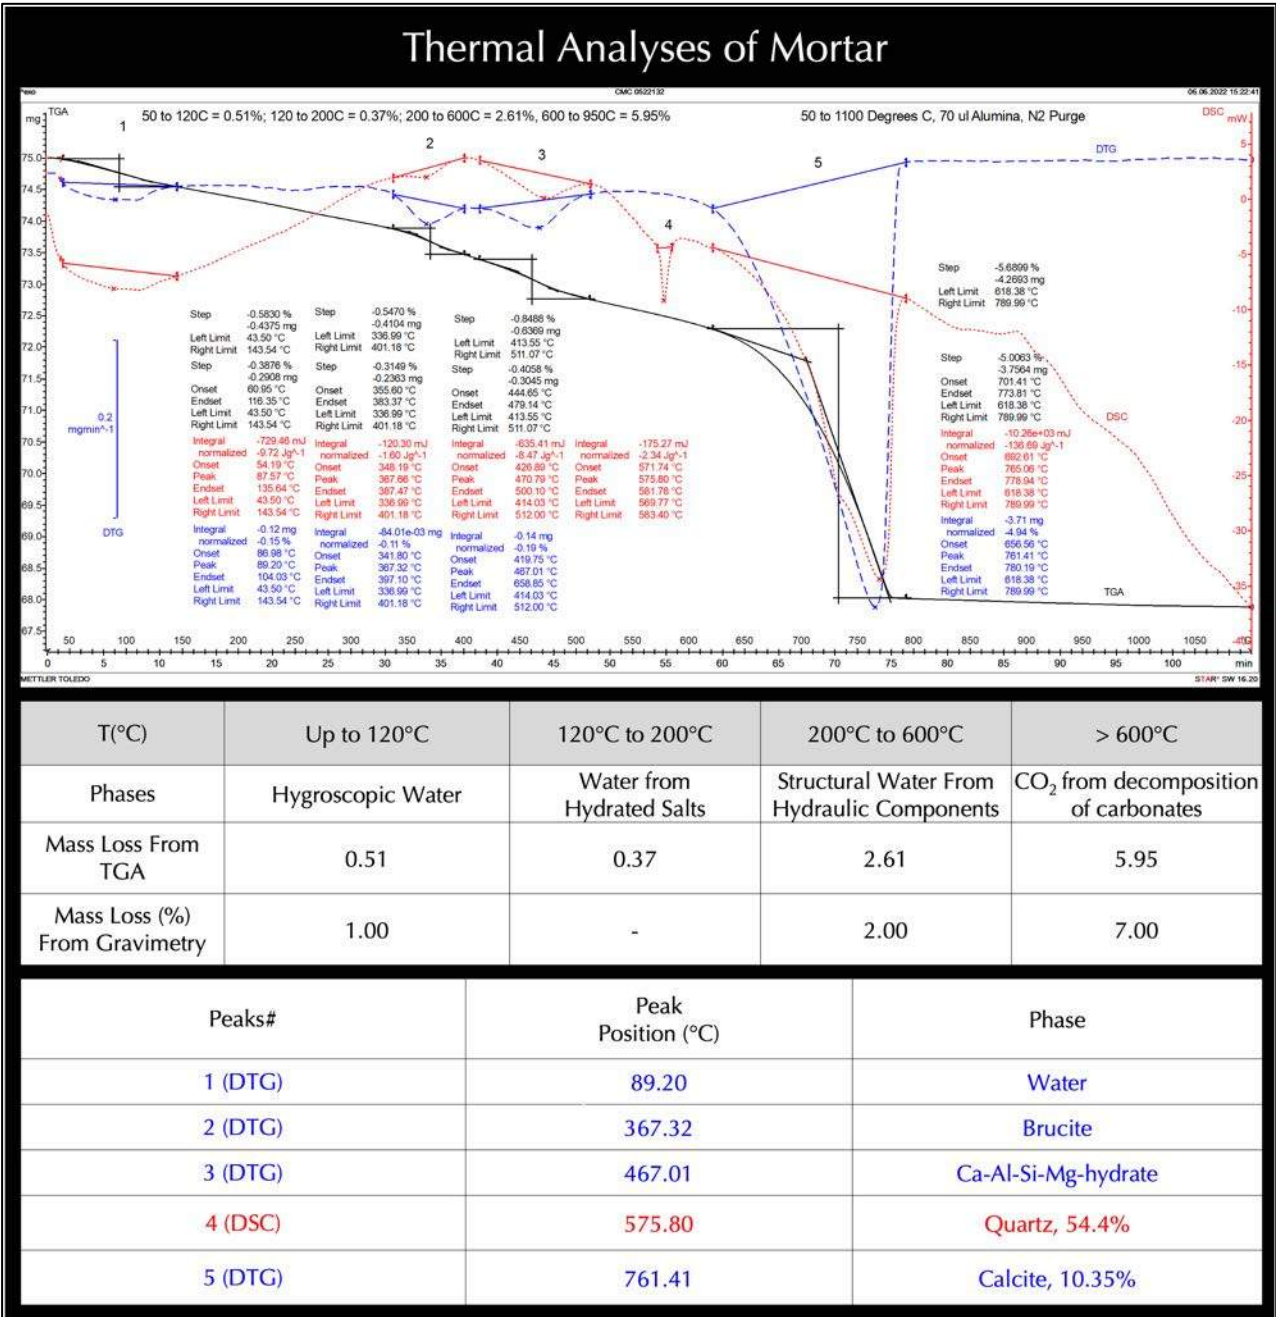
Figure 34: TGA (in bold black), DSC (in dotted red), and DTG (in dashed blue) curves of mortar showing losses in weights due to decompositions (loss of water and carbon dioxide) of various phases during controlled heating in a Mettler-Toledo’s simultaneous TGA/DSC 1 unit from 30°C to 1100°C in a ceramic crucible (alumina 70µl, no lid) at a heating rate of 10°C/min in a nitrogen purge at a rate of 75 mL/min. Dehydration and decarbonation reactions are marked as endothermic peaks in the DTG curve, whereas alpha to beta-form polymorphic transition of quartz is marked at the characteristic temperature of 575°C in the DSC curve. Similar results are obtained from thermal analyses and gravimetry for mass losses from loss of free water (up to 120°C), structural water (200 to 600°C), and carbonation (600 to 950 °C), respectively. Endothermic peaks have confirmed the presence of dolomitic lime putty and a calcined clay binder. DSC curve has provided a quartz content of 54.4 percent (excluding the albite component of sand or calcined clay fraction as found in gravimetry and XRD results).

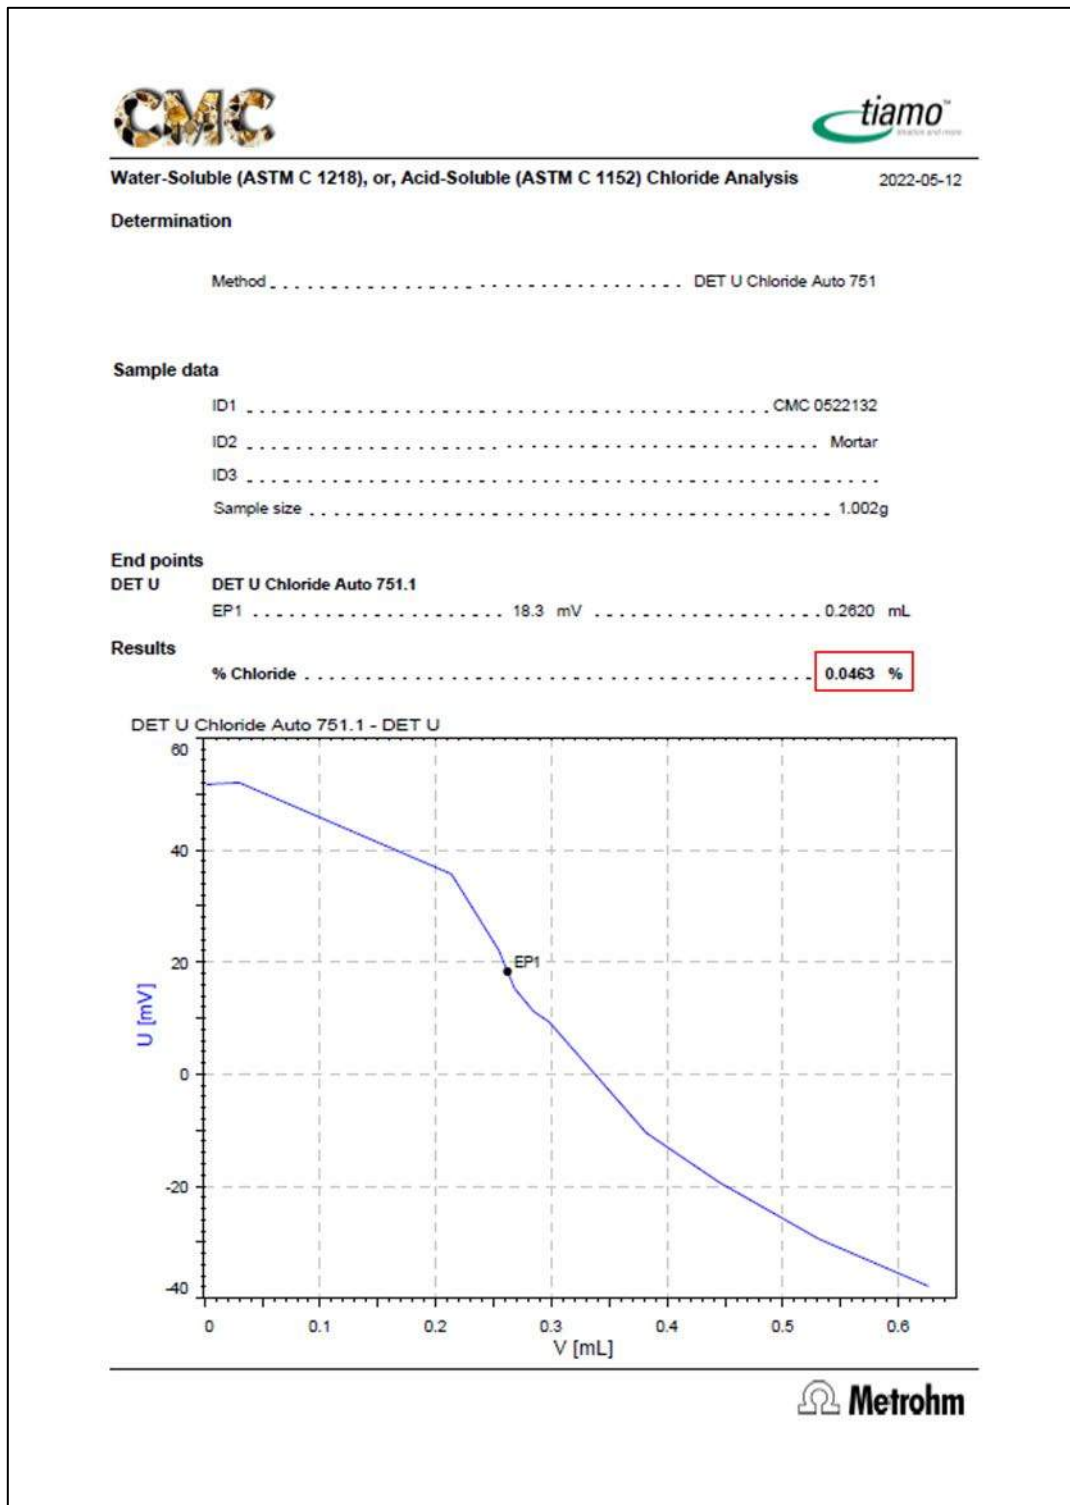
Figure 35: Water-soluble chloride in the mortar after digesting about a gram of pulverized mortar in deionized water for 30 minutes at a temperature below boiling, followed by continued digestion in water at the ambient laboratory condition for 24 hours. The filtrate was analyzed by potentiometric titration with a silver nitrate titrant. Filtrate shows the presence of negligible but detectable chloride.
